KYSTVERKET

Sentralt Styringsdokument for Miljøtiltak ved vraket av U-864

Alternativ 3

Heving av last og tildekking av vrak og forurenset havbunn

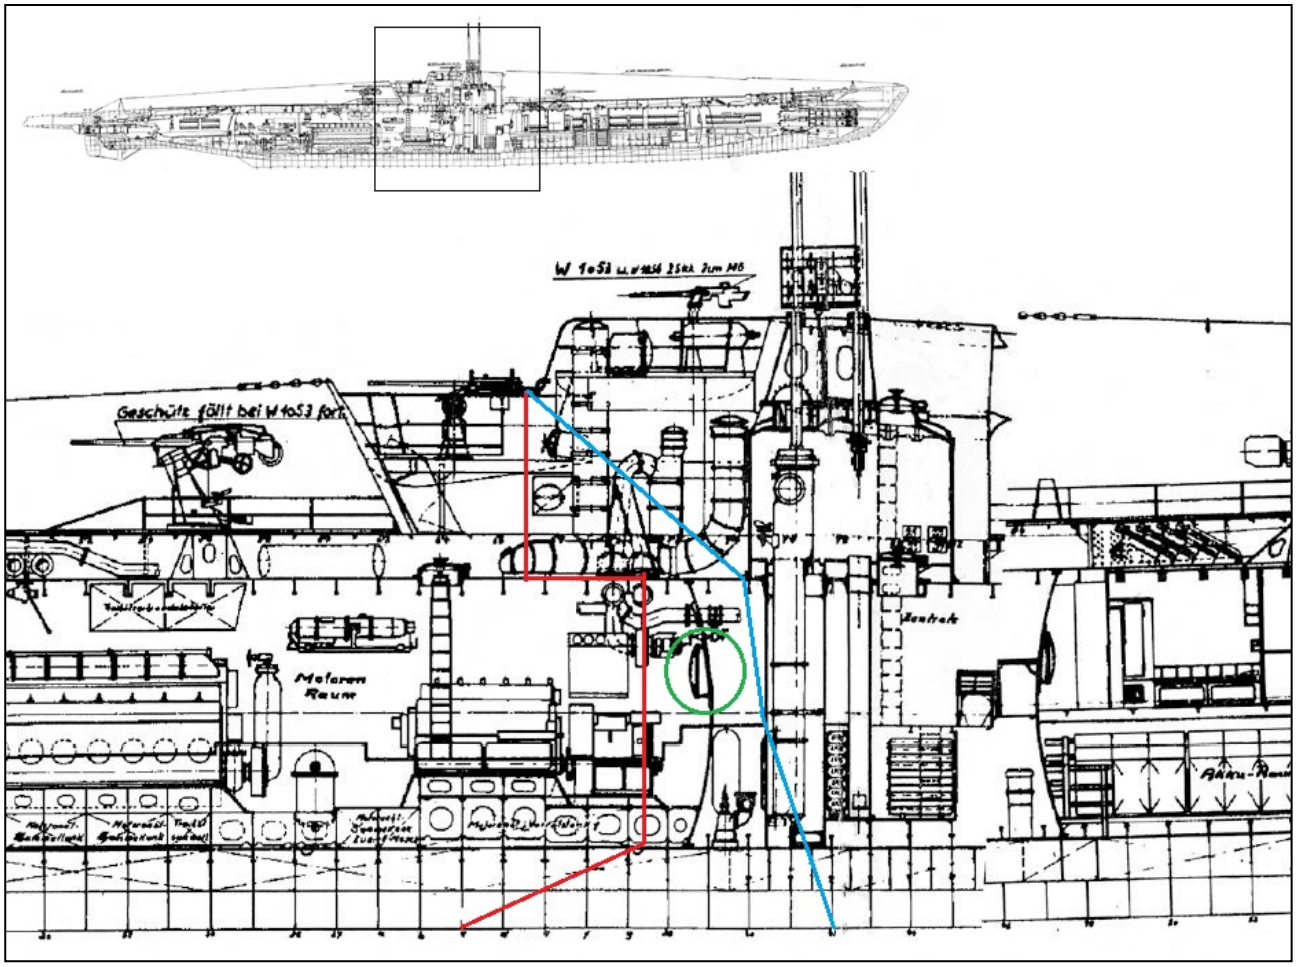
The interior bulkhead was significant in that it allowed the project team to revise the estimated point at which the U boat had been damaged by the torpedo impact (Figure 3.6). The bulkhead was positively identified using an interior water tight hatch as a unique feature (Figure 3.7).

Figure 3.6 **2006 Estimate of extent of wreckage (red) and revised extent (blue). Identifying hatch circled**

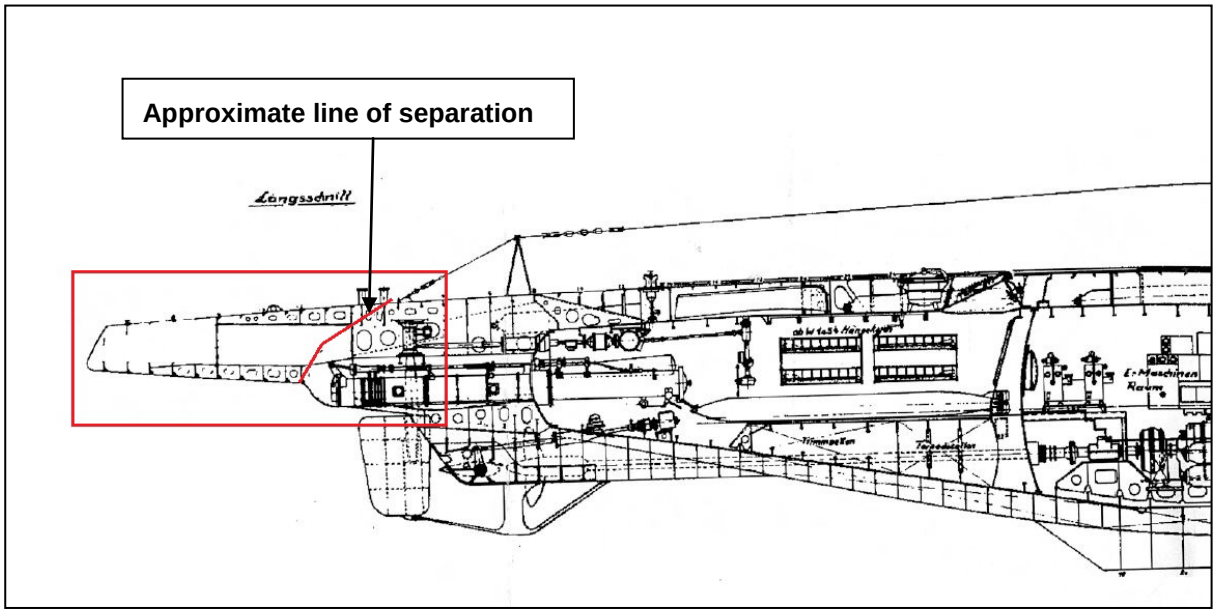
The loss of the extreme stern of the U864 demonstrates the continued deterioration of the wreck (Figure 3.8-Figure 3.12). It should be noted that the dislodged piece does not form part of the vessel's pressure hull but is instead part of the outer streamlined exterior.

Figure 3.8 Stern section schematic showing detached area

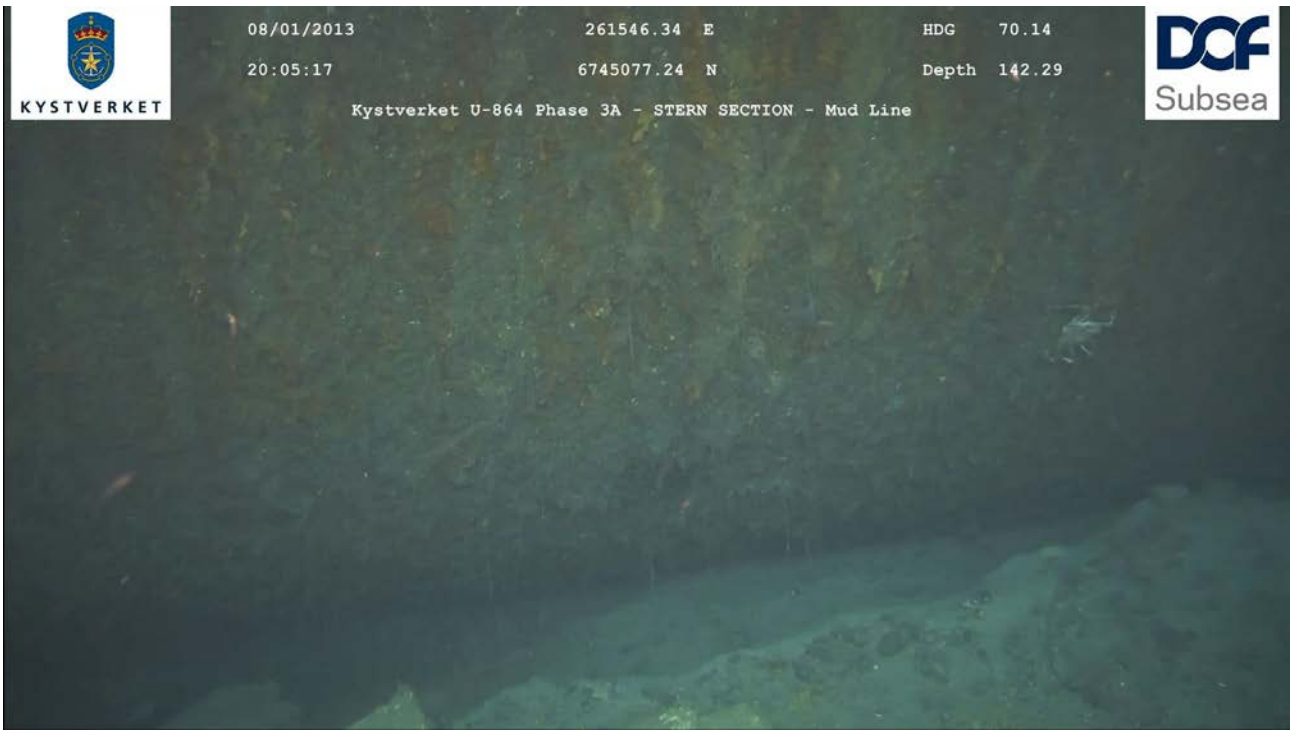
Figure 3.14 The exposed keel (approx. 2.0m) at starboard rear end of the Stern Section

The keel was exposed for approximately 2.5m in length and up to 0.4m in height at the starboard rear end of the Stern Section (Figure 3.13 and Figure 3.14). This has not been reported in Phase 1 or 2. In Phase 2 of the project there was discussions of doing the dredging on starboard side of Stern Section, but because of the amount of debris and the heavy polluted sediments the decision were made for dredging on the port side.

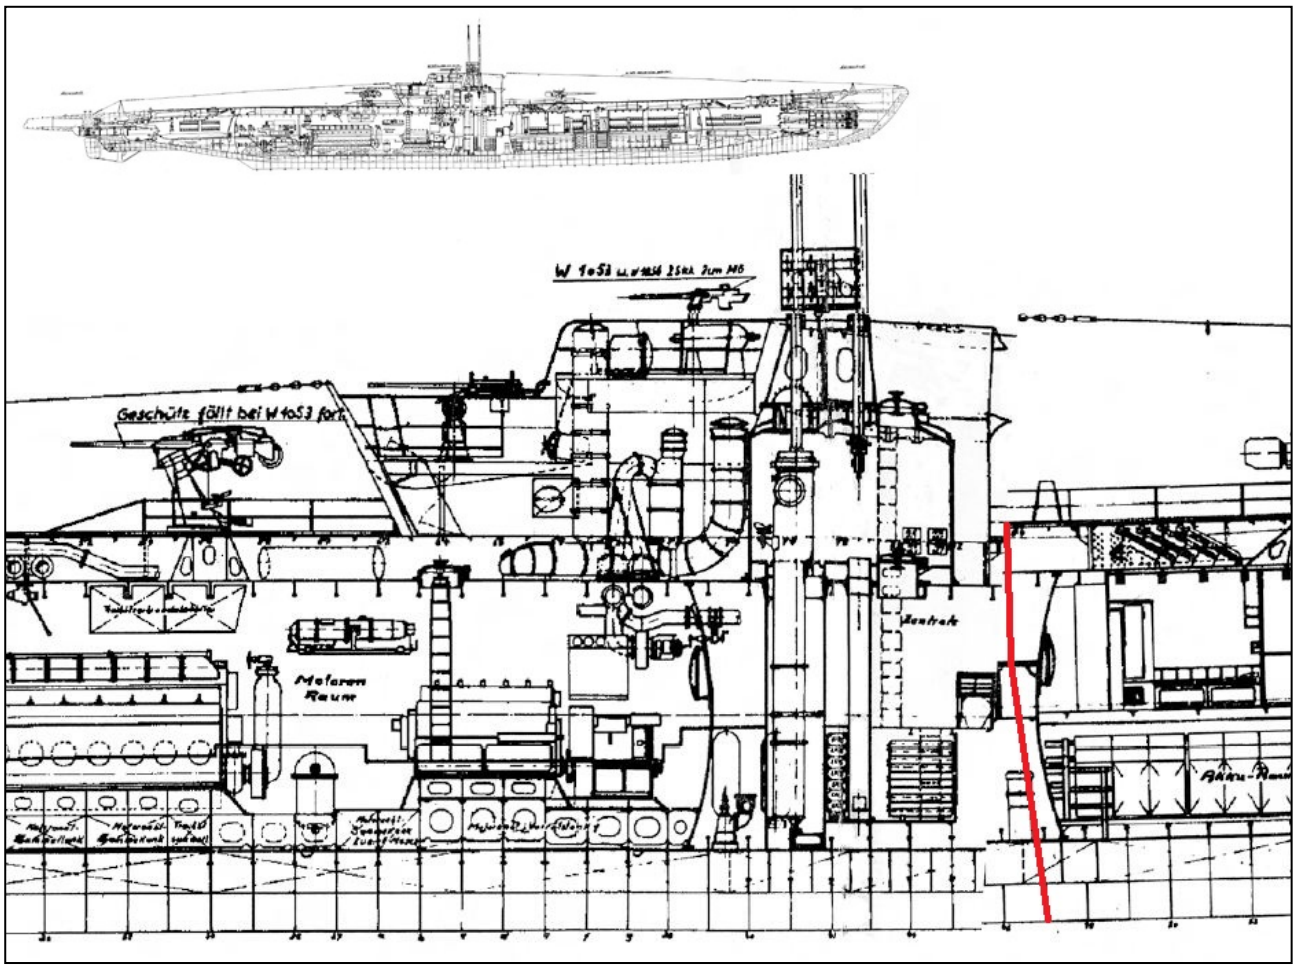
The break point on the bow was reassessed during the survey and found to be similar to the 2006 estimate (Figure 3.15).

Figure 3.15 Approximate break point of the bow wreckage (red)

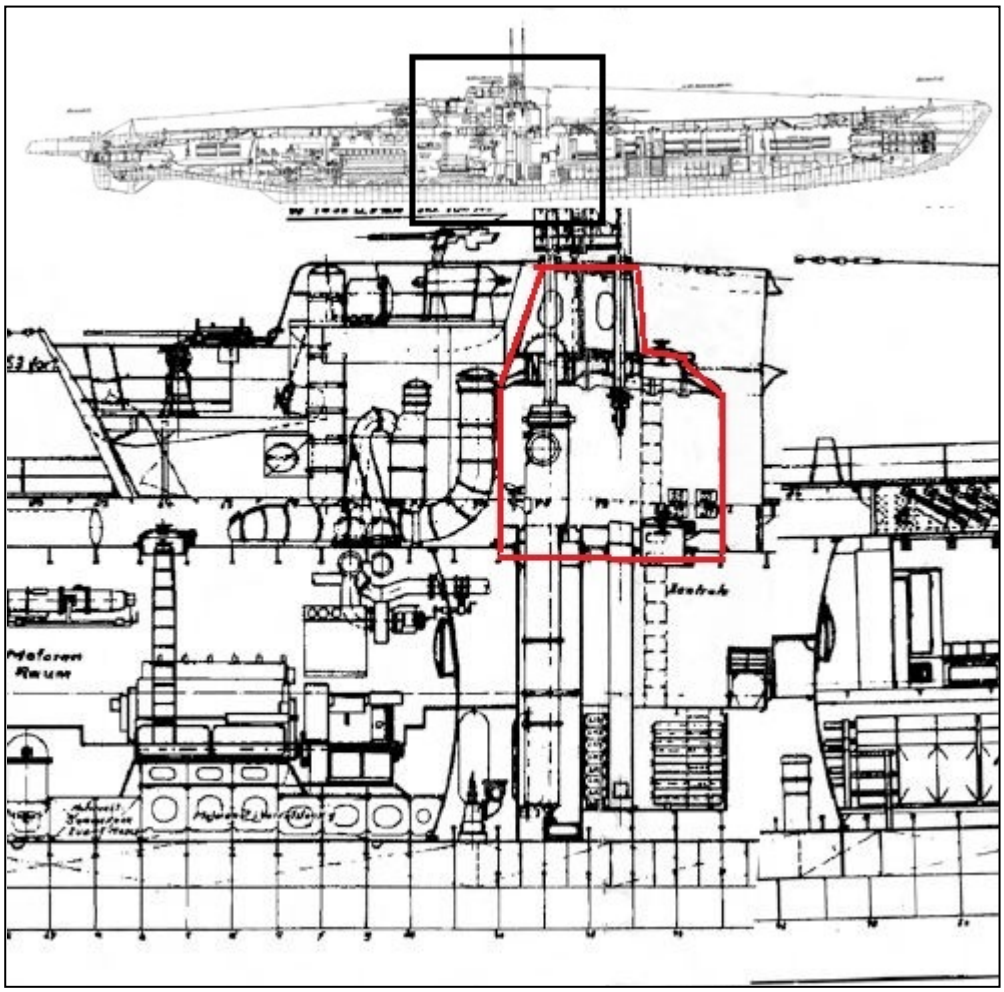
Target 66 was believed to be part of the conning tower of U-864. On closer inspection it was found to comprise the entire pressure (water tight) section of the conning tower (Figure 3.20).

Figure 3.20 Conning tower and control room schematic. Target 66 Highlighted red

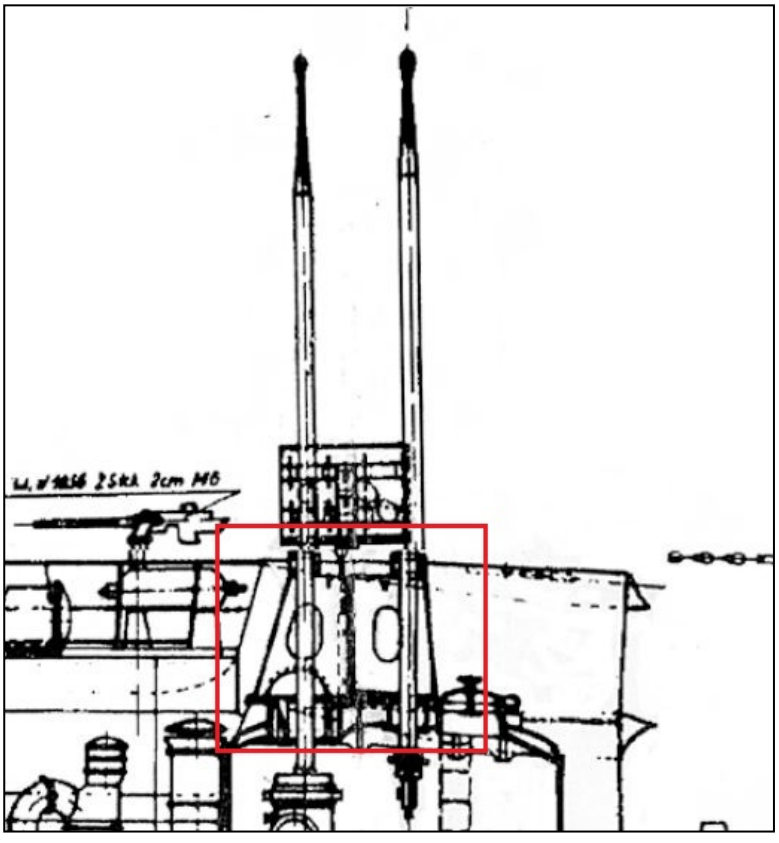
Figure 3.24 U boat schematic showing periscope support structure (highlighted)

Near the detached UZO was identified the very distinctive structure which supported and guided the two periscopes as they were raised and lowered. This structure is again unique to the conning tower (Figure 3.23 & Figure 3.24).

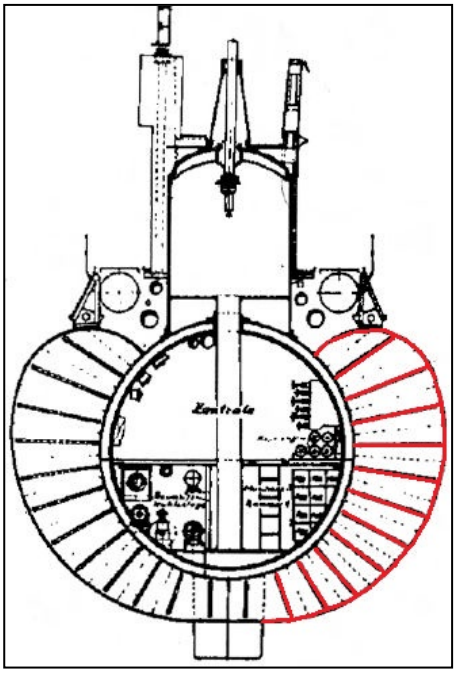
Figure 3.26 Cross section of U boat schematic showing saddle tanks in the area of the control room (Saddle tank highlighted)

Target 15 was identified as a piece of saddle tank from the wreck (Figure 3.25). As the saddle tank is present along the length of the two main wreck sections this could only have come from the central area destroyed by the torpedo explosion. The structure of the frame is also consistent with the construction used in the saddle tank in the area of the control room (Figure 3.26).

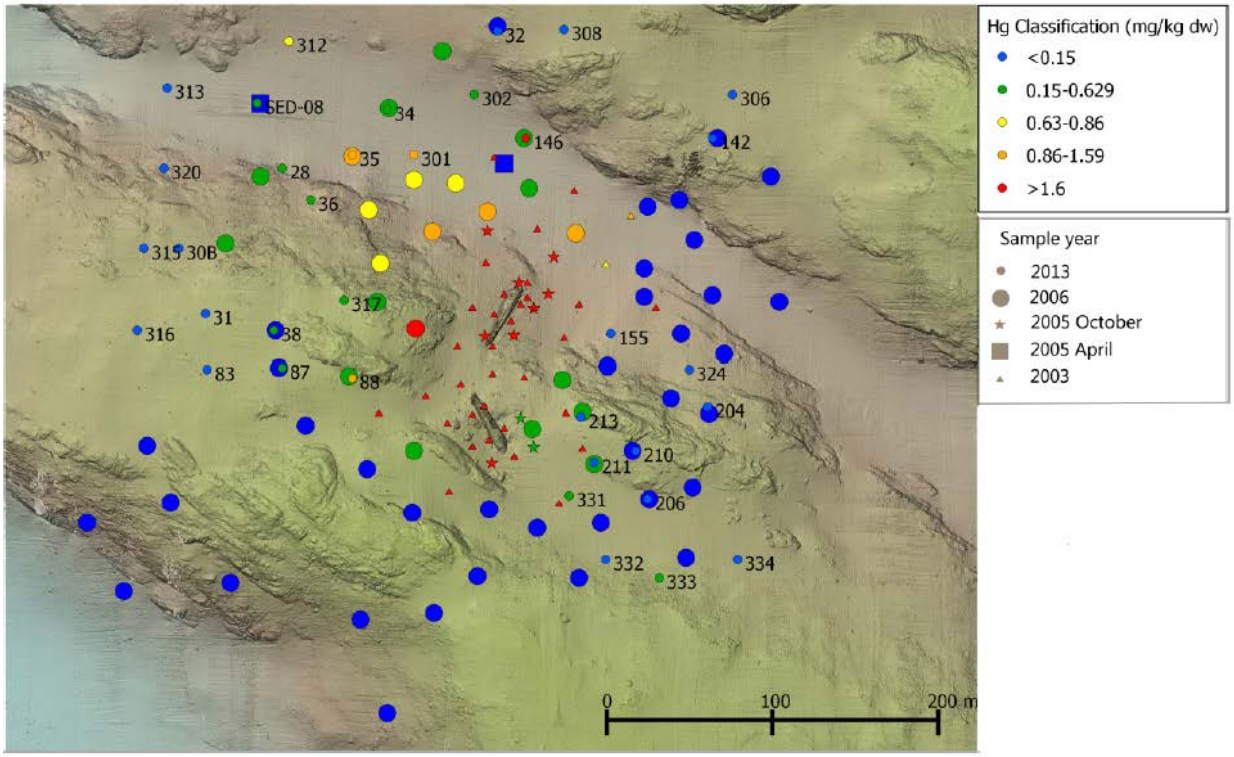
Figure 3.29 From NIVA report (ref /4/); Mercury content results for all years

The results from all of the analyses done for previous years (2003, 2005, 2006 and 2013) are presented in the Figure 3.29 below, from NIVA report (ref /4/). This figure (Figure 3.29) illustrate that all samples classified as moderately polluted (Class III), bad (Class IIII) or very bad (Class V) are all located in the near vicinity of the wreck and west or north of the wreck. Samples taken east or south of the wreck is classified as good (Class II) or background (Class I).

The positions of the samples with highest mercury contamination agree with the direction of the water current (north western direction).

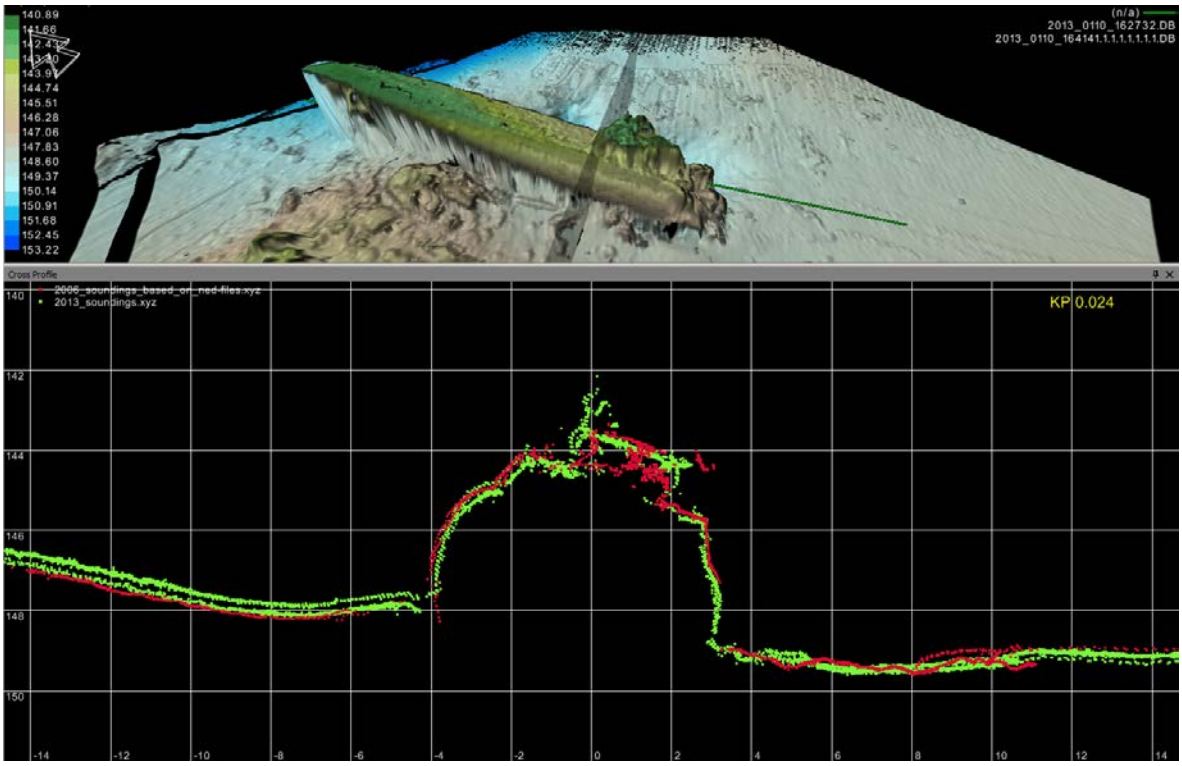
From the evidence available it is believed that any movement of the stern section is negligible. It should be noted that there is an apparent movement between the two available data sets but this is due to a small piece of wreckage becoming dislodged from the very stern of the wreck. See Paragraph 0 for more details.

Figure 3.30 **Comparison of 2006 (red) and 2013 (green). Shaded area in top image shows cross section location**

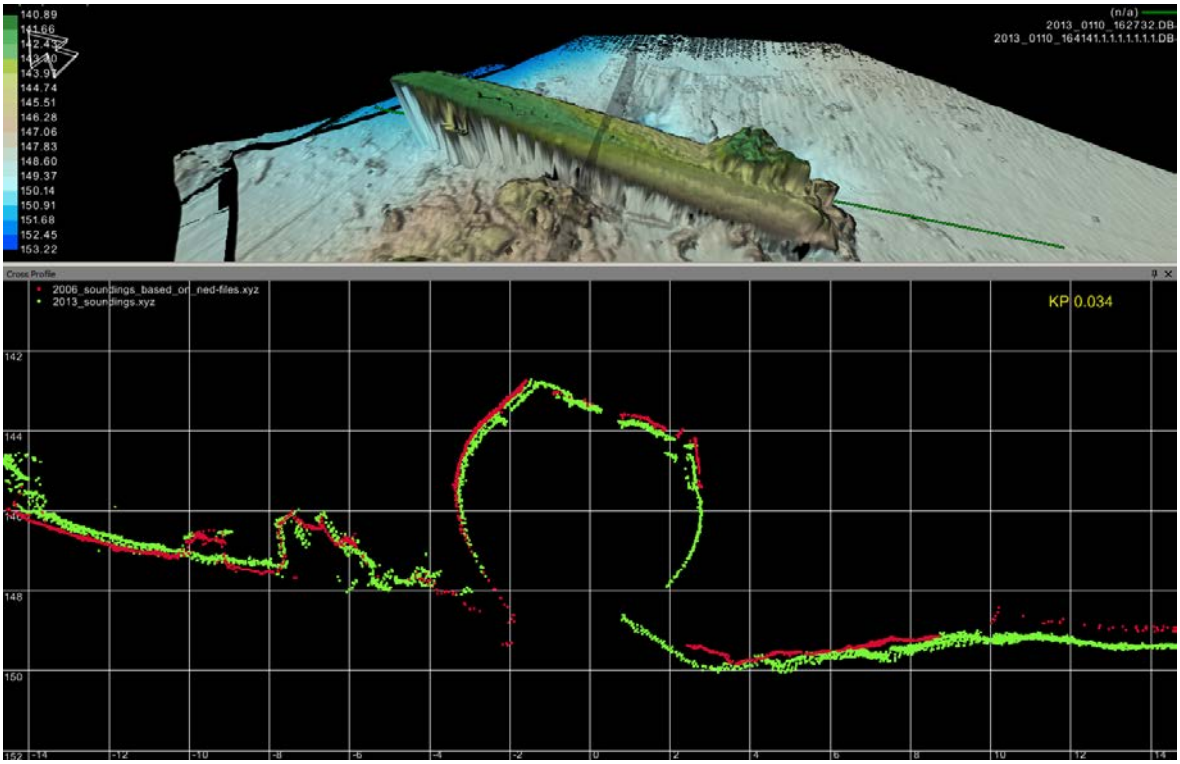
Figure 3.31 **Comparison of 2006 (red) and 2013 (green). Shaded area in top image shows cross section location**

A comparison of MBE data collected during the previous survey in 2006 and that collected during Phase 3A was conducted in order to identify any movement of the stern section of the wreck. Profiles were compared every 2m along the length of the stern section. An example of the compared profiles are shown below (Figure 3.30, Figure 3.31 and Figure 3.32) and all compared profiles are shown in Paragraph 4.5.

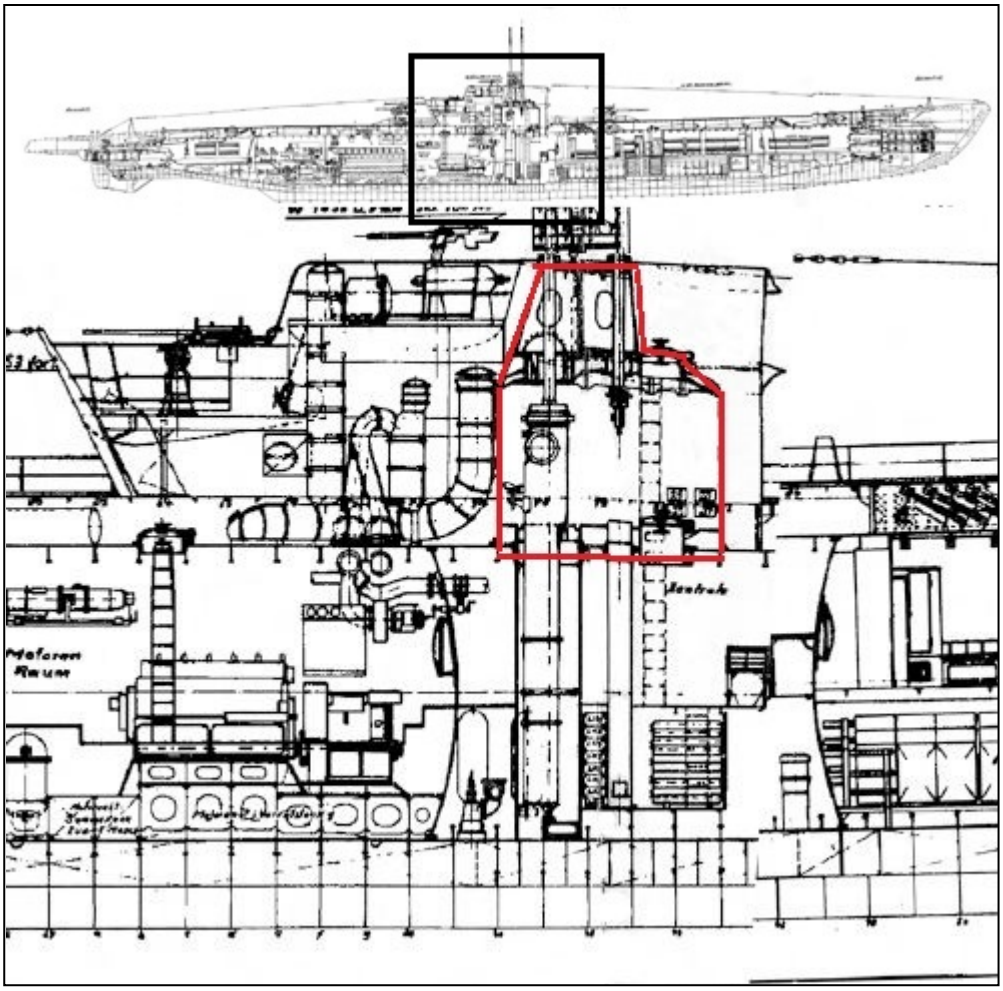
Figure 4.8 Conning tower and control room schematic. Target 66 Highlighted red

Target 66 was believed to be part of the conning tower of U-864, on closer inspection it was found to comprise the entire pressure (water tight) section of the conning tower (Figure 4.8).

Target 66 was found to be laying on its side, with the upper part of the structure pointing to the East. The features of the upper conning tower were clearly visible on this part of the wreckage.

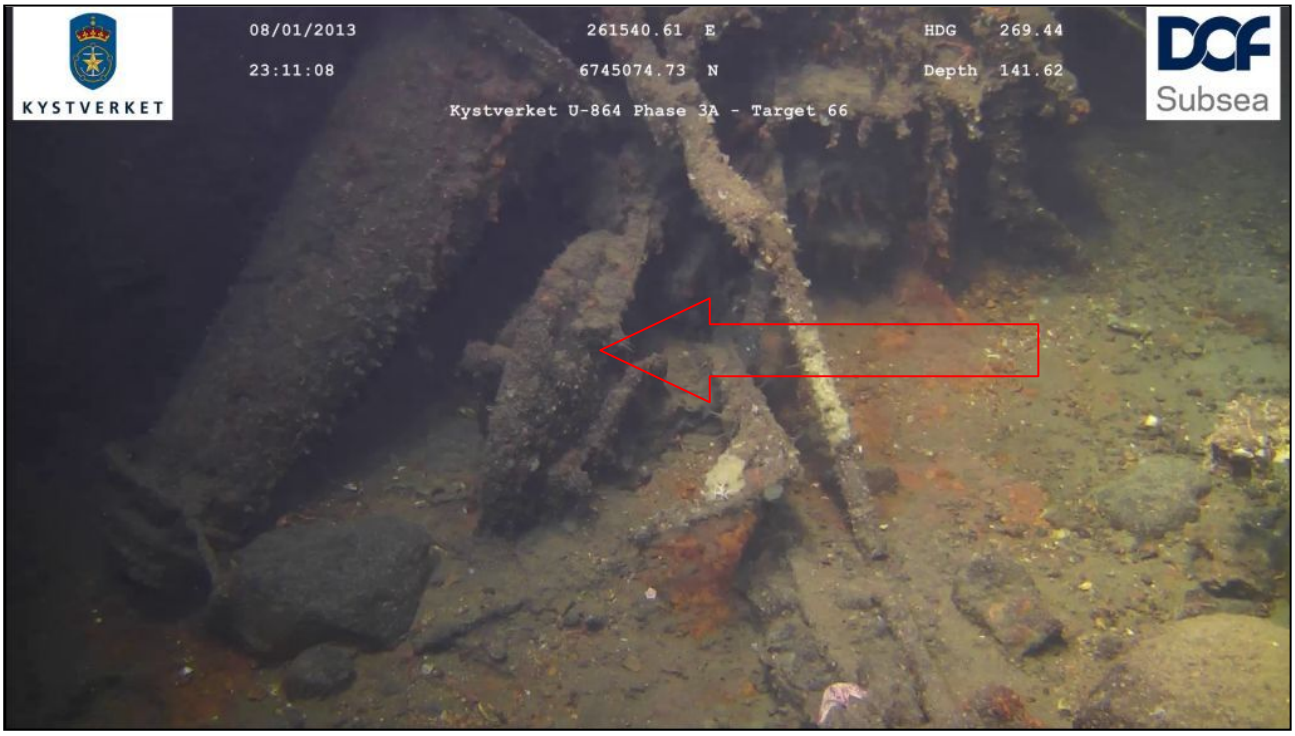
Figure 4.10 **Upper Conning Tower hatch**

In close proximity to the previously discussed UZO was a small hatch which provided access to the interior of the tower from the observation area. On the lower part of target 66 was a corresponding hatch which provided access from the tower to the control room as seen in Figure 4.9.

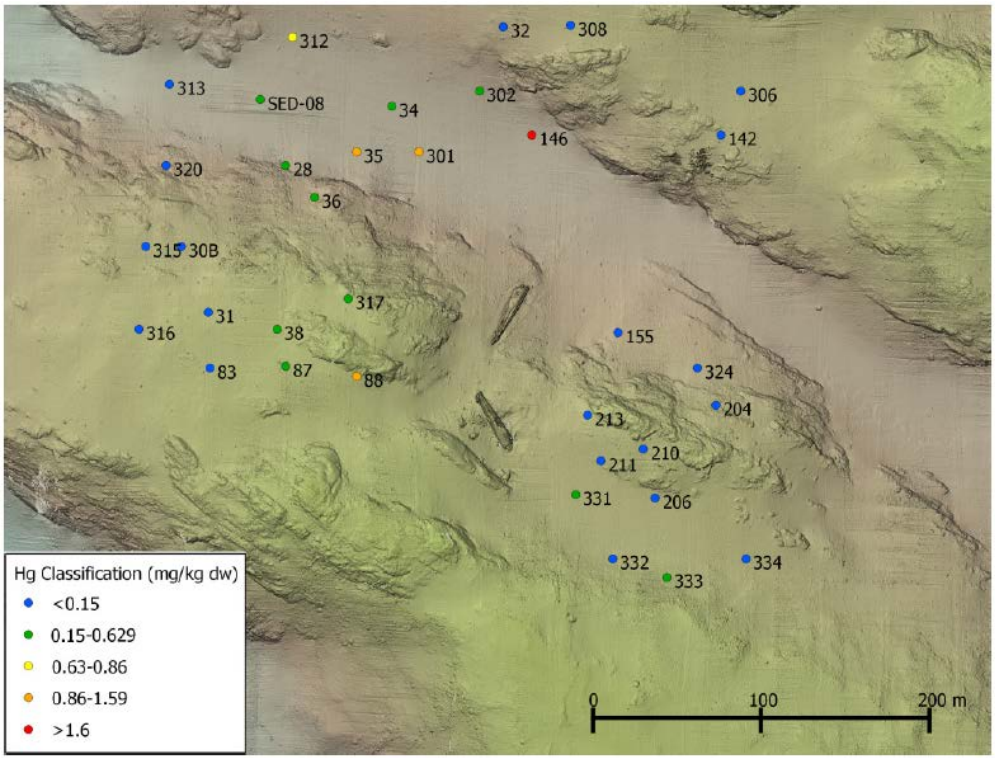
Figure 4.14 From NIVA report (ref /4/); mercury content in surface sediment (0-2cm) 2013

The results from the 2013 mercury content analyses of the soil samples are shown in Figure 4.14 below, from NIVA report (ref /4/).

16 of the 35 soil samples were taken at same locations as samples from 2006, and 5 of these showed an increase in mercury content of more than 0,2 Hg (mg/kg). These five are listed in the

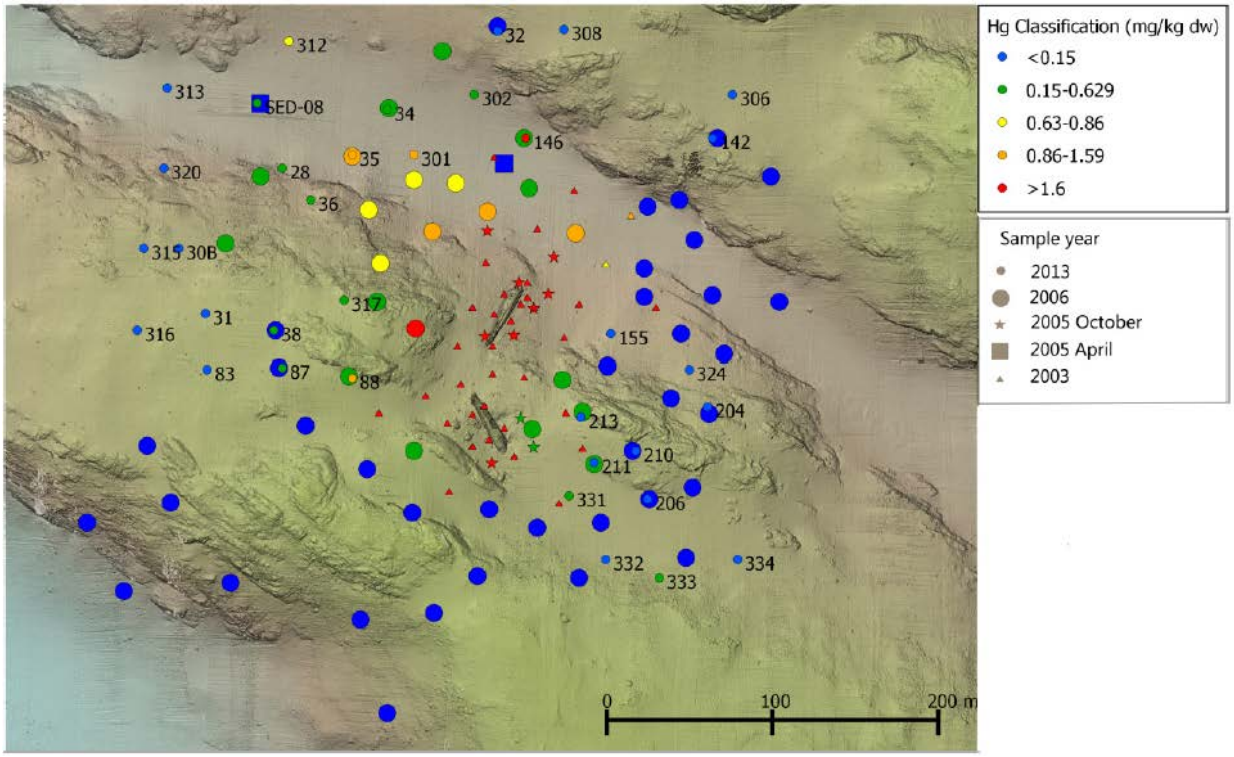
Figure 4.15 From NIVA report (ref /4/); Mercury content results for all years

The compilation of all the mercury analyses in the figure above (Figure 4.15) show that all samples classified as moderately polluted (Class III), bad (Class IIII) or very bad (Class V) are all located in the near vicinity of the wreck and west or north of the wreck. Samples taken east or south of the wreck is classified as good (Class II) or background (Class I).

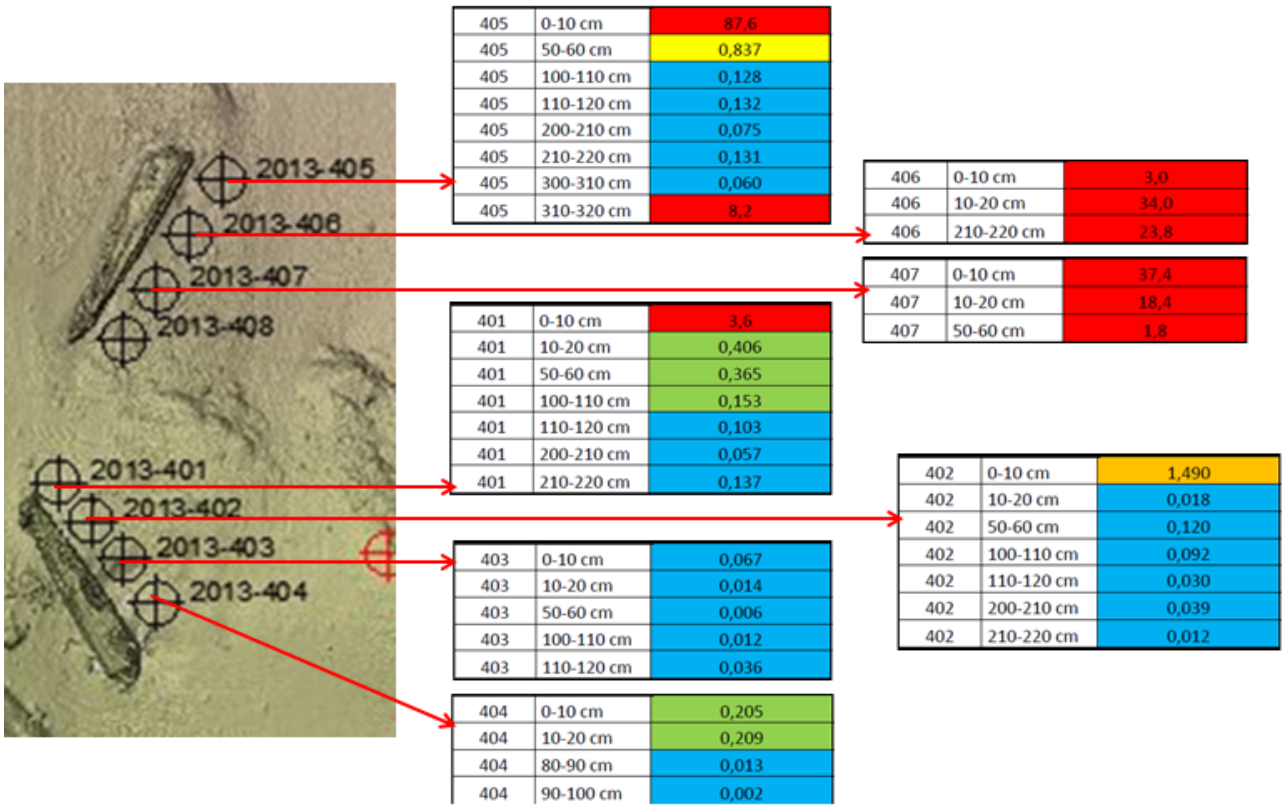
Figure 4.16 Mercury analyses in vibrocores close to wreck

The results from the vibrocores taken near the wreck all show a general high surface concentration of mercury (Figure 4.16), with decreasing contamination with sediment depth (ref /4/).

As seen from Figure 4.16 the mercury surface content in sample 2013-403 and 404 are low. This is most likely due to the dredging of surface sediments in this area in 2006. Sample 2013-402 is a few meters away from the dredged area.

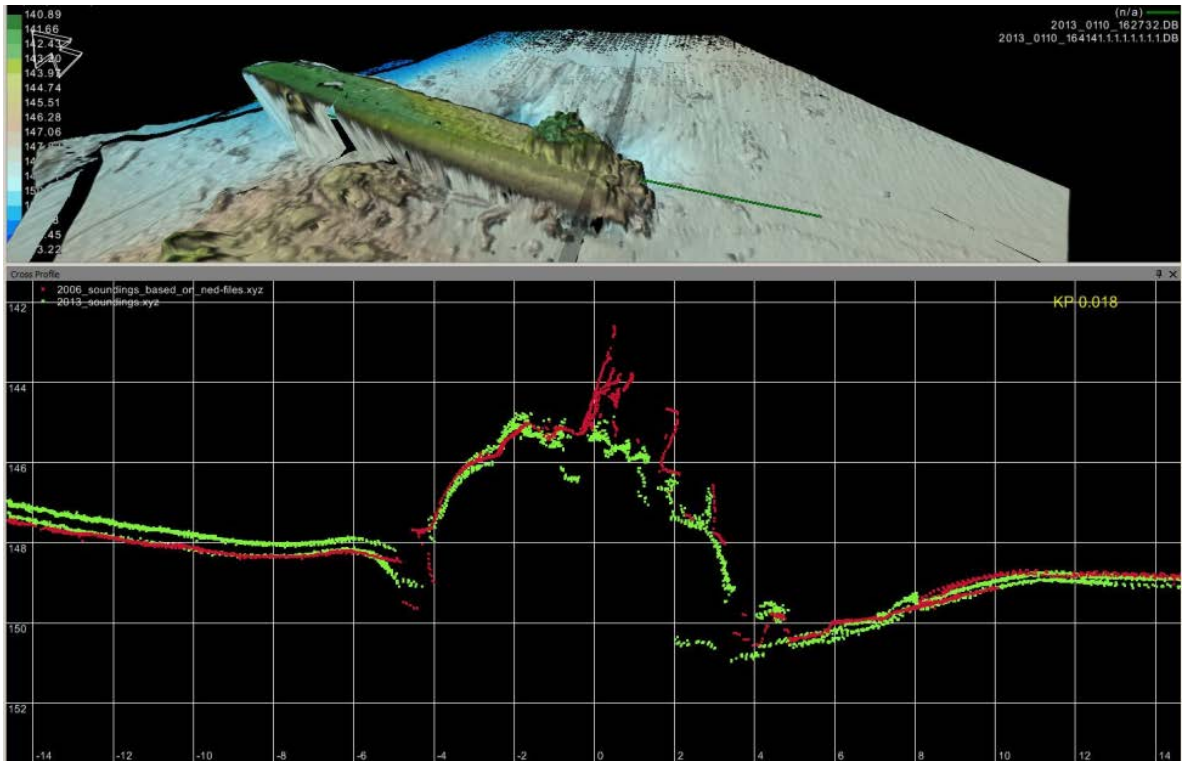
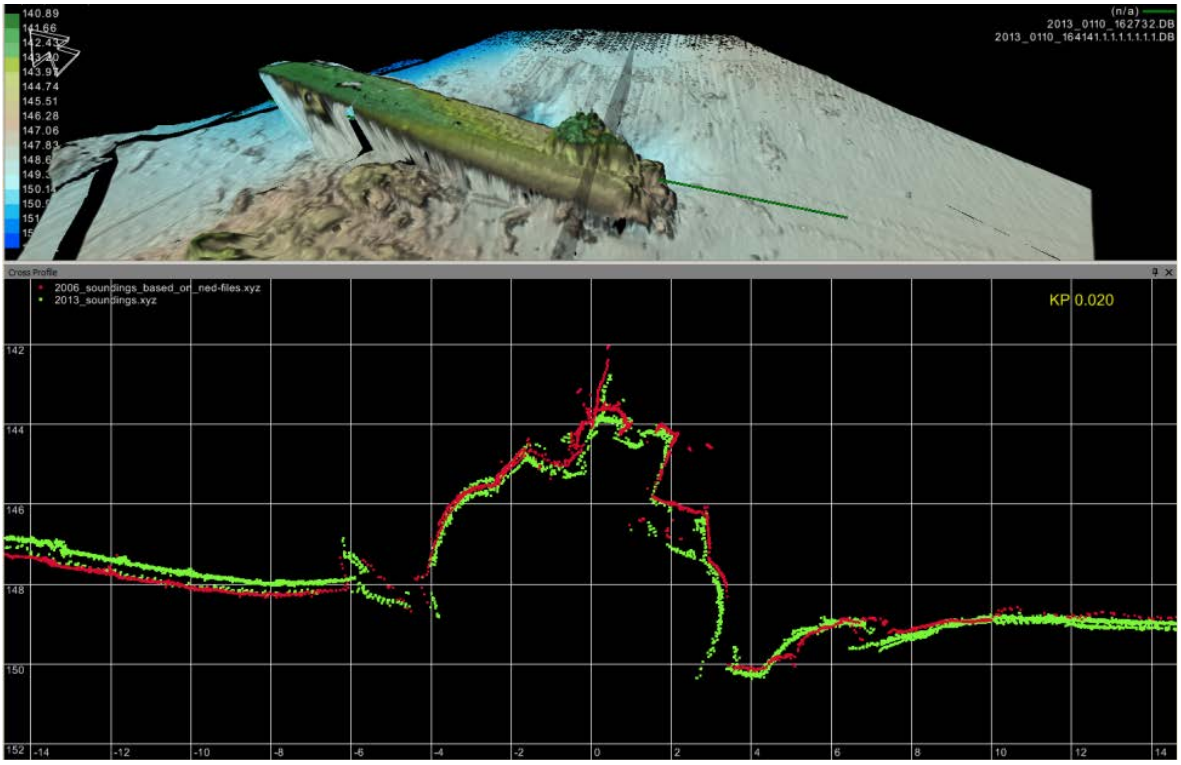
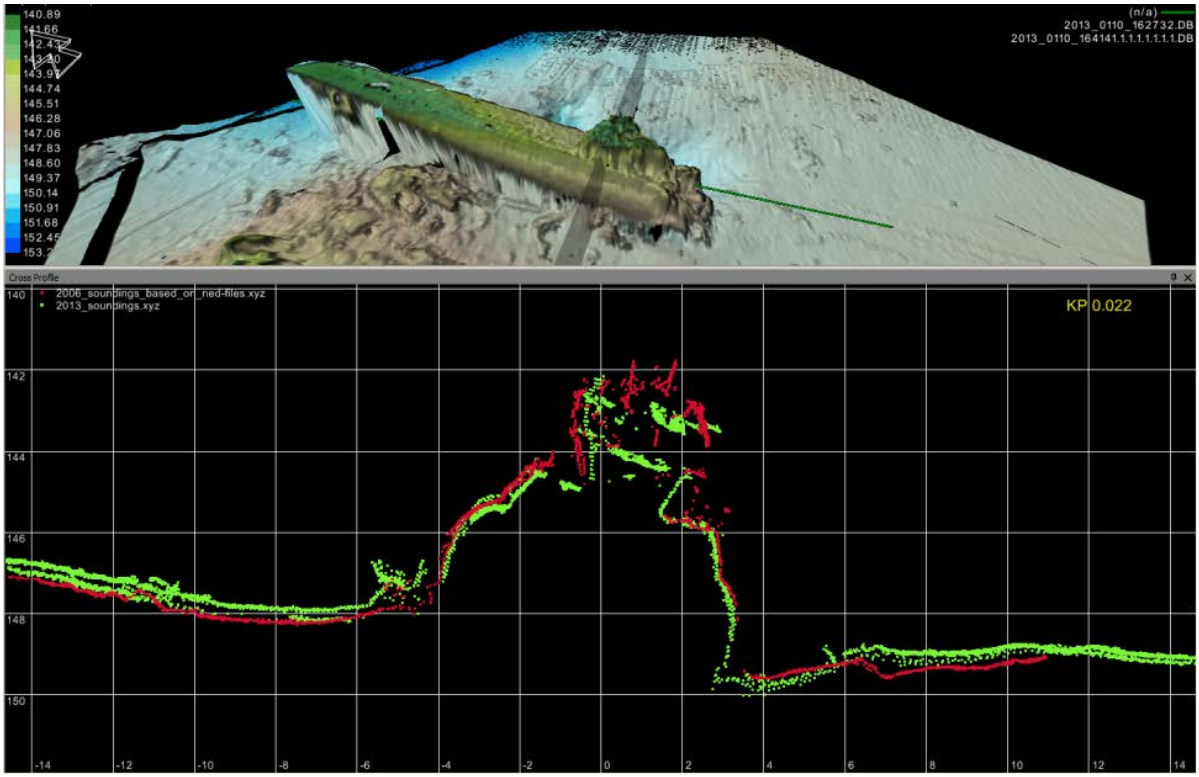
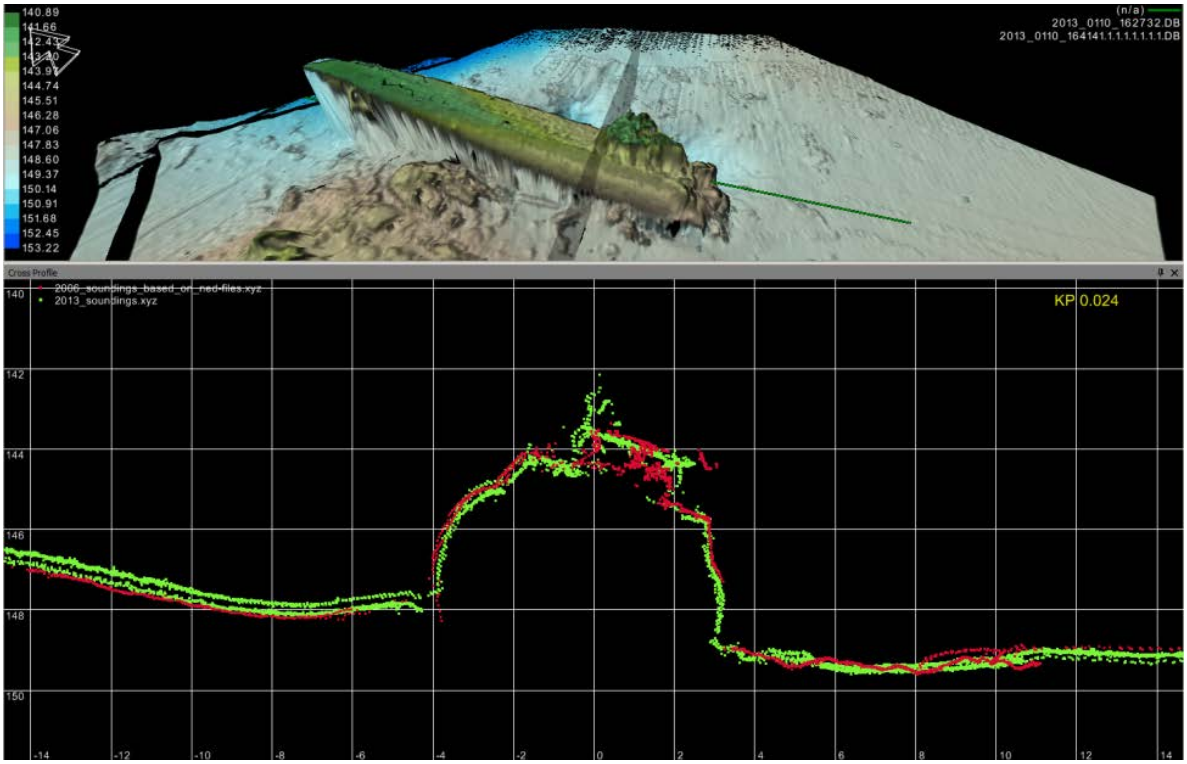
A comparison of MBE data collected during the previous survey in 2006 and that collected during Phase 3A was conducted in order to identify any movement of the stern section of the wreck. Profiles were compared every 2m along the length of the stern section. An example of the compared profiles are shown below.

From the evidence available it is believed that any movement of the stern section is negligible. It should be noted that there is an apparent movement between the two available data sets but this is due to a small piece of wreckage becoming dislodged from the very stern of the wreck. See Paragraph 0 for more details.

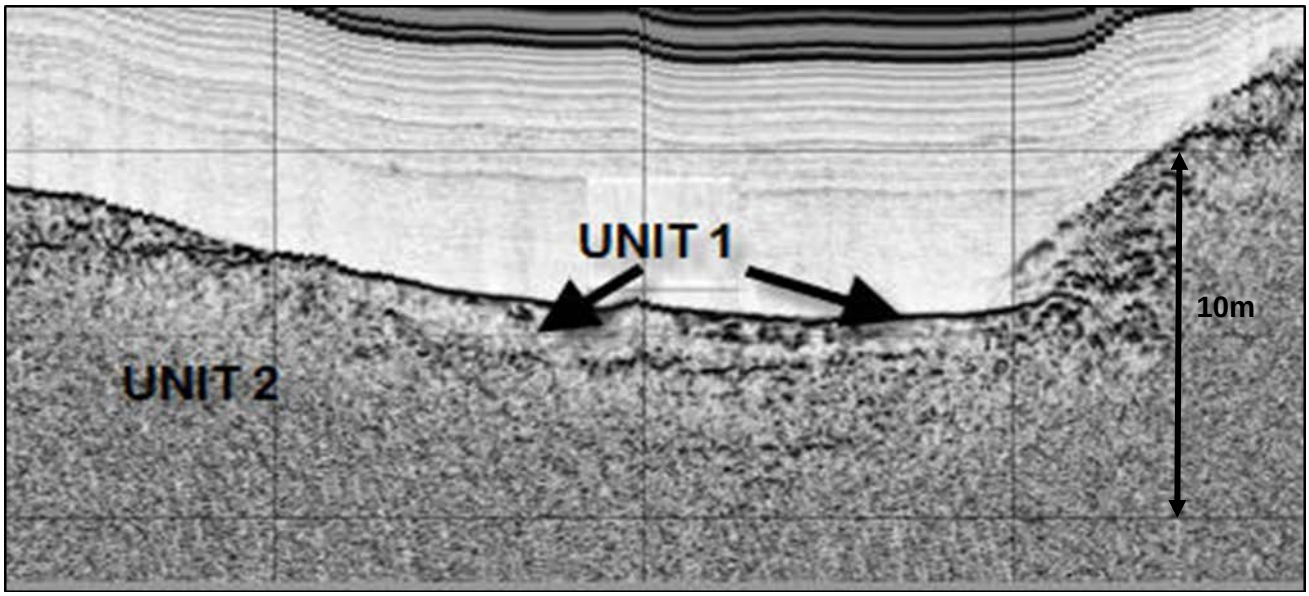
Figure 4.38 SBP data example from Line 8, showing Unit 1 & 2

The data acquired was good throughout the survey, however due to the seabed characteristics the penetration achieved was limited.

This limited penetration was caused by the presence of a surficial layer of sand throughout the survey area.

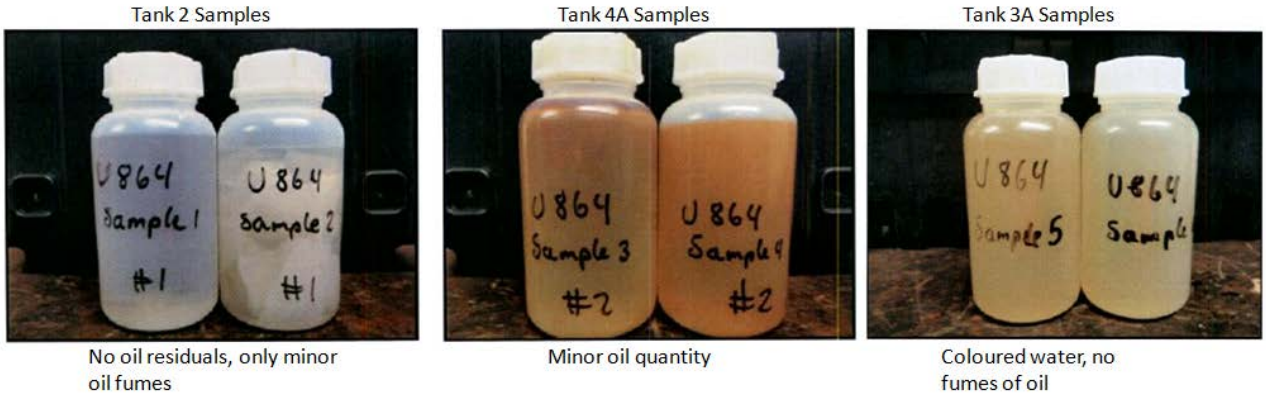
Figure 4.40 Oil recovery samples (ref /5/)

The conditions of the weld seems for the outer shell of the fuel tanks were found in a poor condition. Due to the poor state of condition, the focus changed during operation from oil recovery to verification survey for most of the fuel tanks. If there were any uncertainty, oil recovery of a tank was commenced.

Oil recovery was done for 3 of the 16 tanks on the U-864 (tank 4A, 2 and 3A), and only minor quantities of oil was recovered from those 3 tanks (Figure 4.40).

No further oil residuals or any leakage were observed at the final survey.

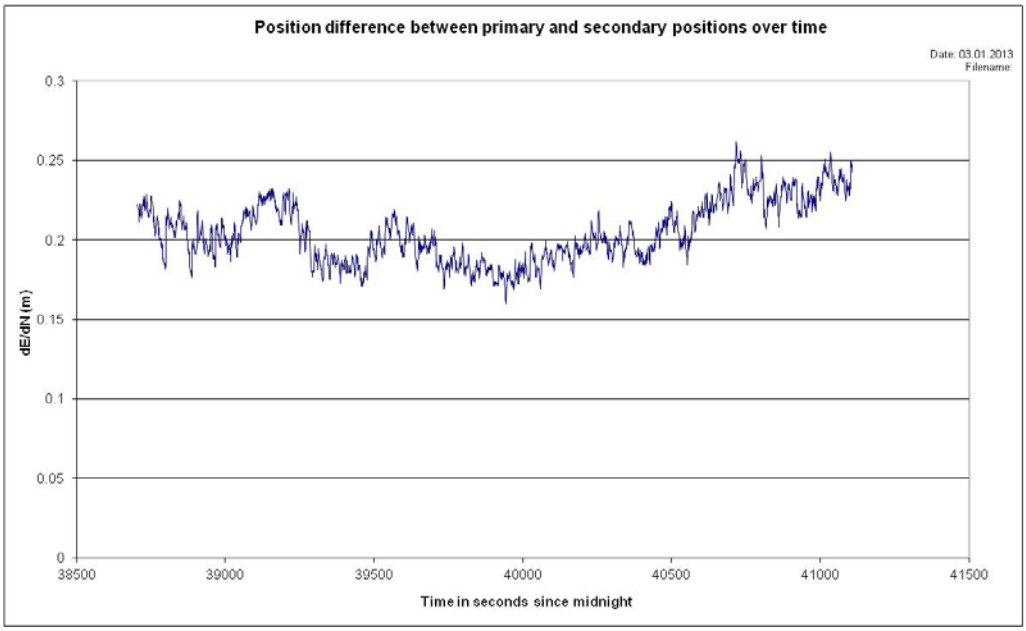
Figure 7-1 Position difference between HP and XP systems, 3rd January 2013

A comparison between the survey navigation systems, Fugro XP/HP was carried out during the vessel mobilisation on 3rd January 2013.

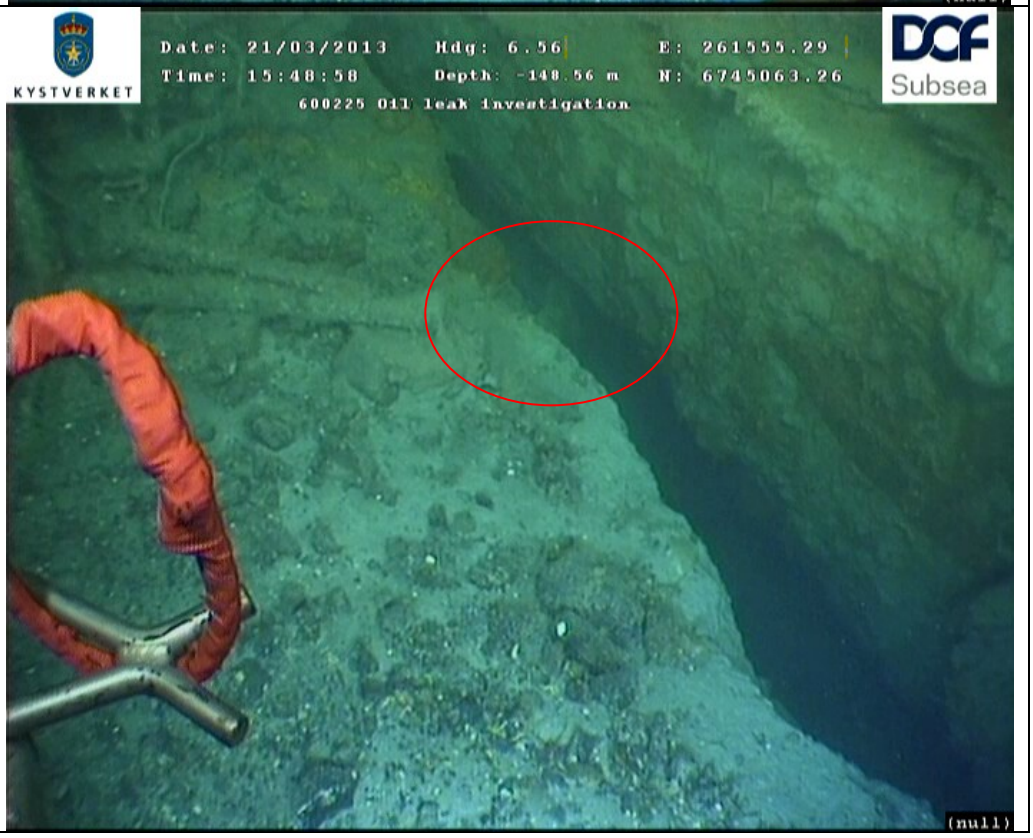
Oil leak was found to come from where we did the first cut to release air at aft section #1. Oil was also spotted coming out from several cracks in the outer fuel tanks.
Leak rate was measured and recorded on DVR over a period of 60 minutes. Approximately 3 dl of oil was captured during this period.
