KYSTVERKET

Sentralt Styringsdokument for Miljøtiltak ved vraket av U-864

Alternativ 3

Heving av last og tildekking av vrak og forurenset havbunn

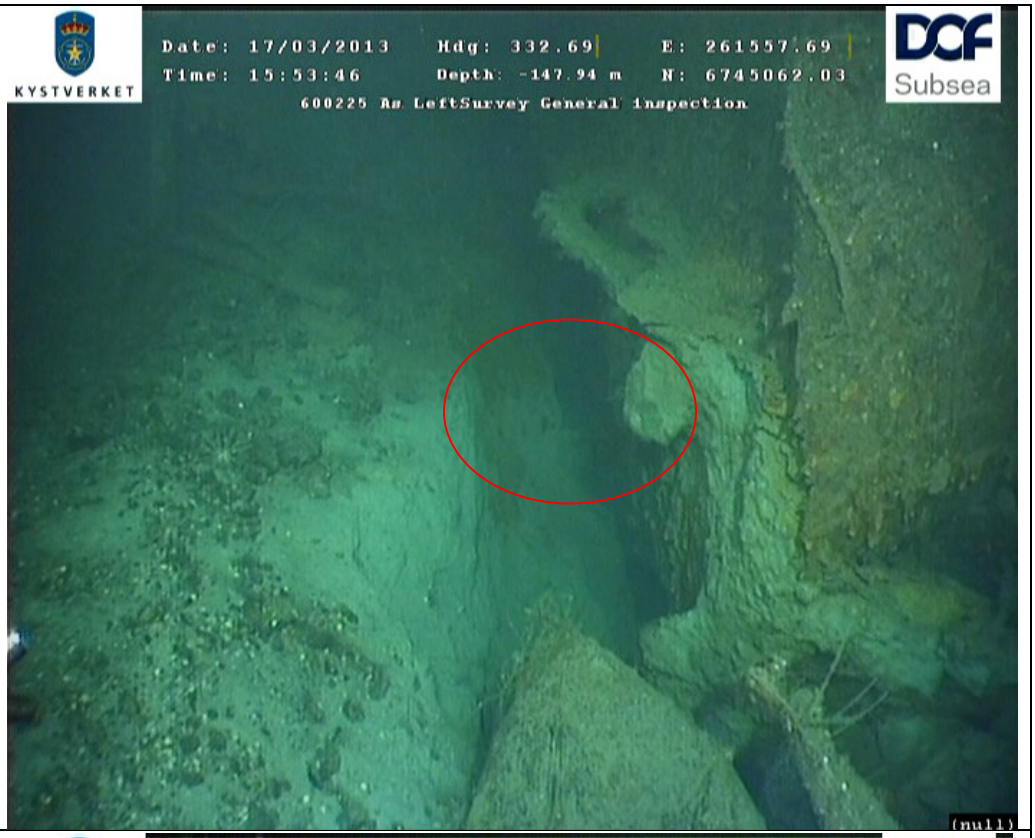
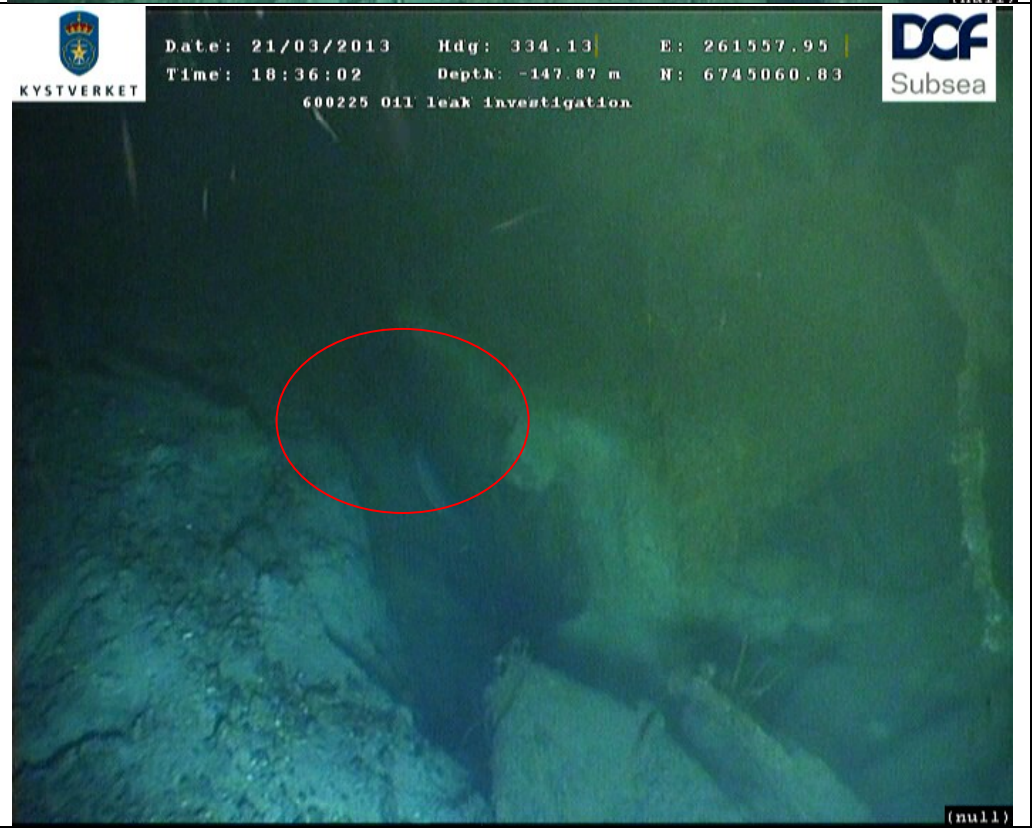
1. Debris resting towards U-864. 17.03.2013
2. Debris resting towards U-864. 21.03.2013
3. Mud gap. 17.03.2013
4. Mud gap. 21.03.2013
5. Debris resting towards U-864. 17.03.2013
6. Debris resting towards U-864. 21.03.2013
7. Start of Oil Leak Rate test. Yellow rings on each 0,5 litre.
8. End of Oil Leak Rate Test. Approx 0.3 litre inside bottle
9. Close up of Oil
10. Oil trapped in wreck
11. Measurement stick. Readings approx 1.1 metre
12. Measurement stick. Readings approx 1.1 metre

1	 KYSTVERKET Date: 17/03/2013 Hdg: 6.77 E: 261554.65 Time: 15:04:36 Depth: -147.55 m N: 6745062.37 600225 Au LeftSurvey Stbd - Mud Line DOF Subsea (null)
2	 KYSTVERKET Date: 21/03/2013 Hdg: 6.56 E: 261555.29 Time: 15:48:58 Depth: -148.56 m N: 6745063.26 600225 Oil leak investigation DOF Subsea (null)

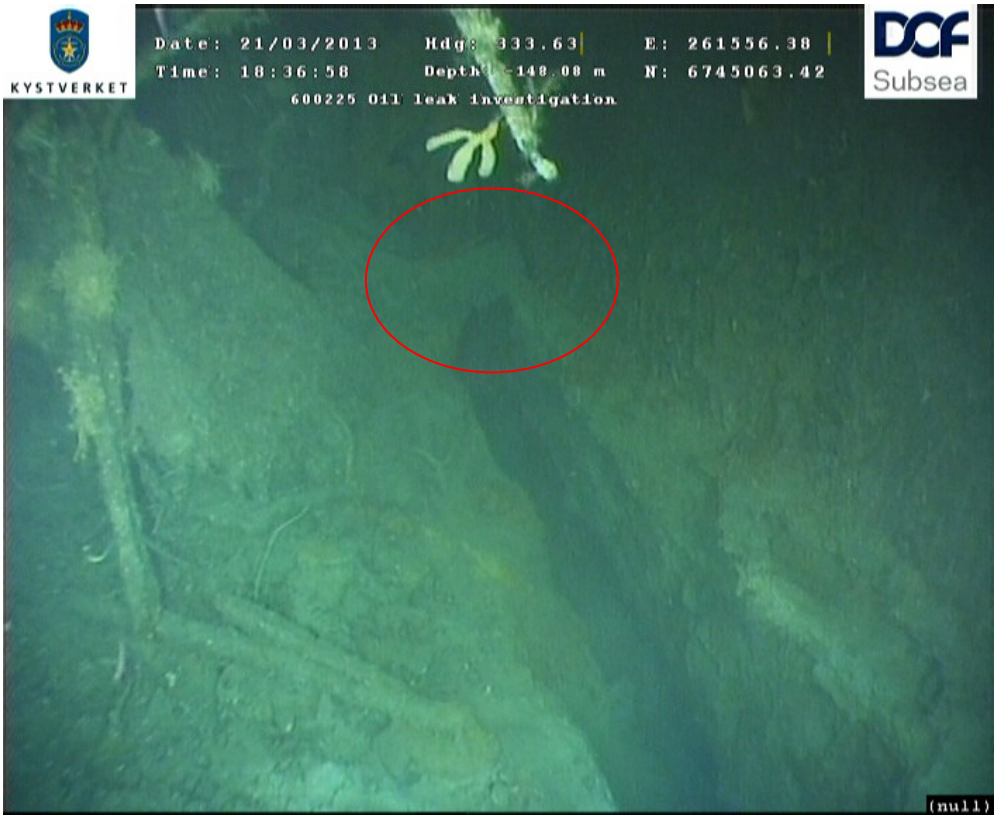
3	 KYSTVERKET Date: 17/03/2013 Hdg: 332.69 E: 261557.69 Time: 15:53:46 Depth: -147.94 m N: 6745062.03 600225 Ra LeftSurvey General inspection DOF Subsea (null)
4	 KYSTVERKET Date: 21/03/2013 Hdg: 334.13 E: 261557.95 Time: 18:36:02 Depth: -147.87 m N: 6745060.83 600225 Oil leak investigation DOF Subsea (null)

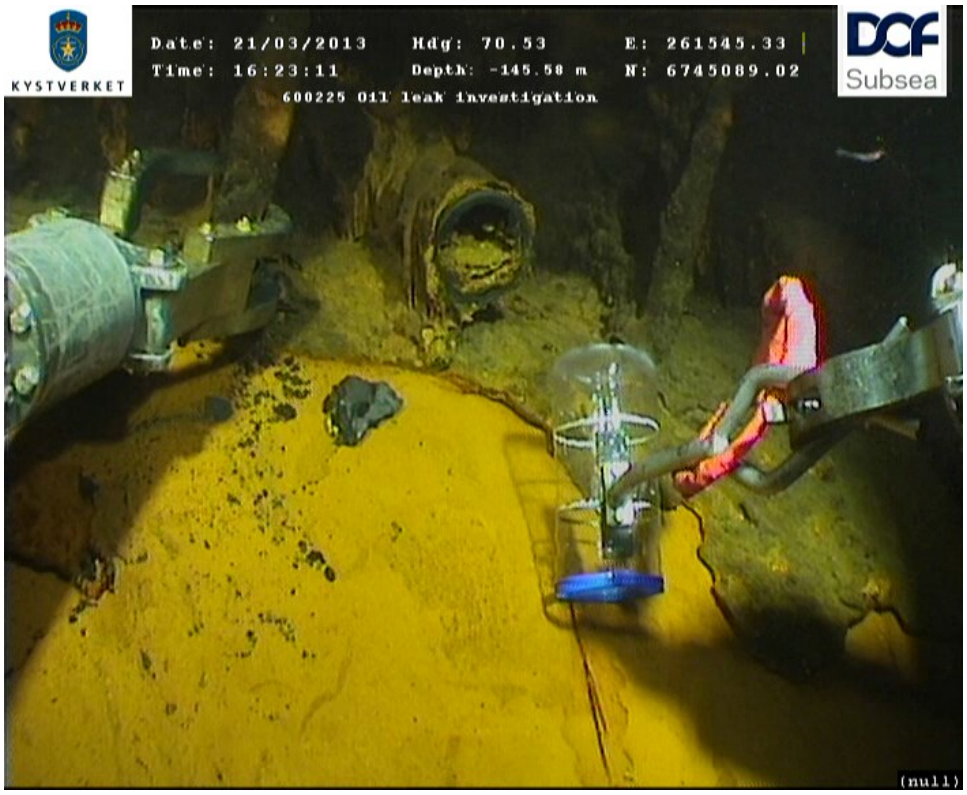
5	 KYSTVERKET Date: 17/03/2013 Hdg: 326.73 E: 261557.20 Time: 15:54:19 Depth: -146.99 m N: 6745062.11 600225 Av LeftSurvey General inspection DOF Subsea (null)
6	 KYSTVERKET Date: 21/03/2013 Hdg: 333.63 E: 261556.38 Time: 18:36:58 Depth: -148.08 m N: 6745063.42 600225 Oil leak investigation DOF Subsea (null)

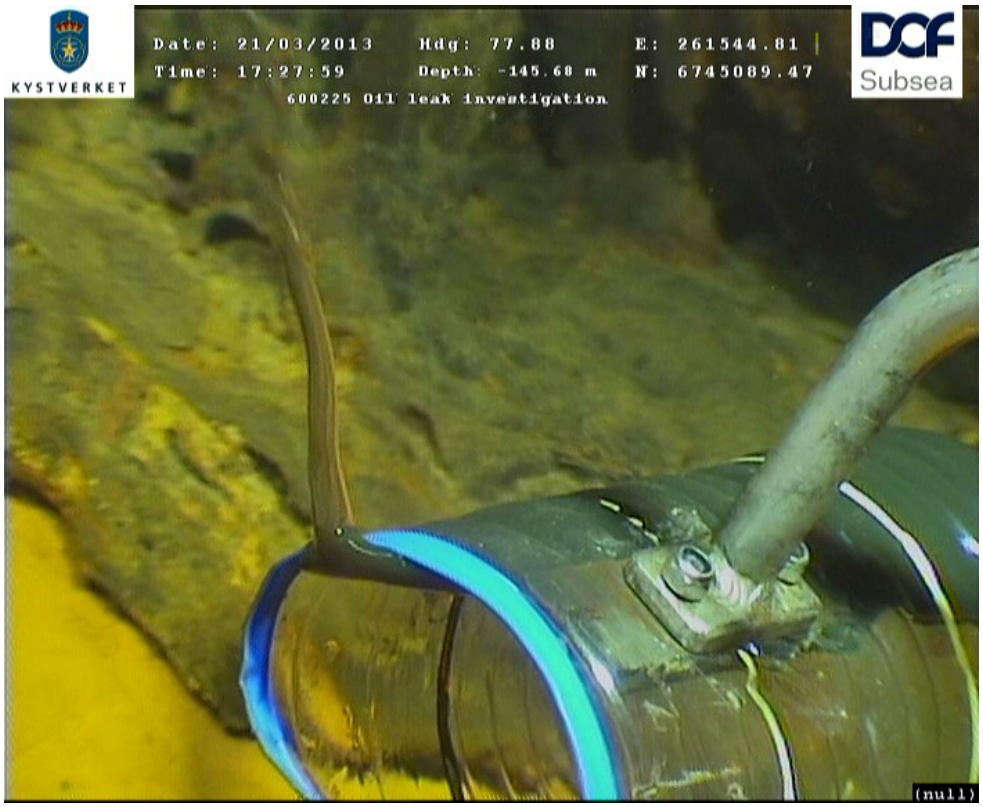
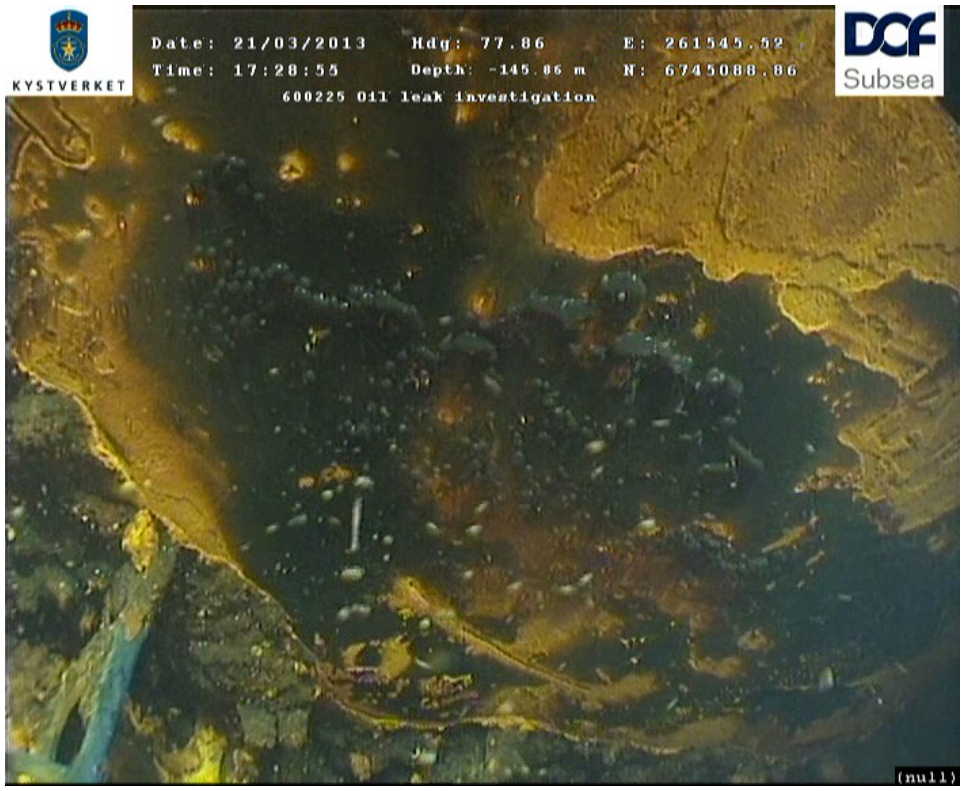
7	 KYSTVERKET Date: 21/03/2013 Hdg: 70.53 E: 261545.33 Time: 16:23:11 Depth: -145.58 m N: 6745089.02 600225 Oil leak investigation DOF Subsea (null)
8	 KYSTVERKET Date: 21/03/2013 Hdg: 77.90 E: 261544.98 Time: 17:24:13 Depth: -145.91 m N: 6745089.48 600225 Oil leak investigation DOF Subsea (null)

Oil leak level was measured to be approx 0.3L in 60 minutes. Upon arriving location, no oil was visible on surface from bridge level. It was no wind and calm sea.

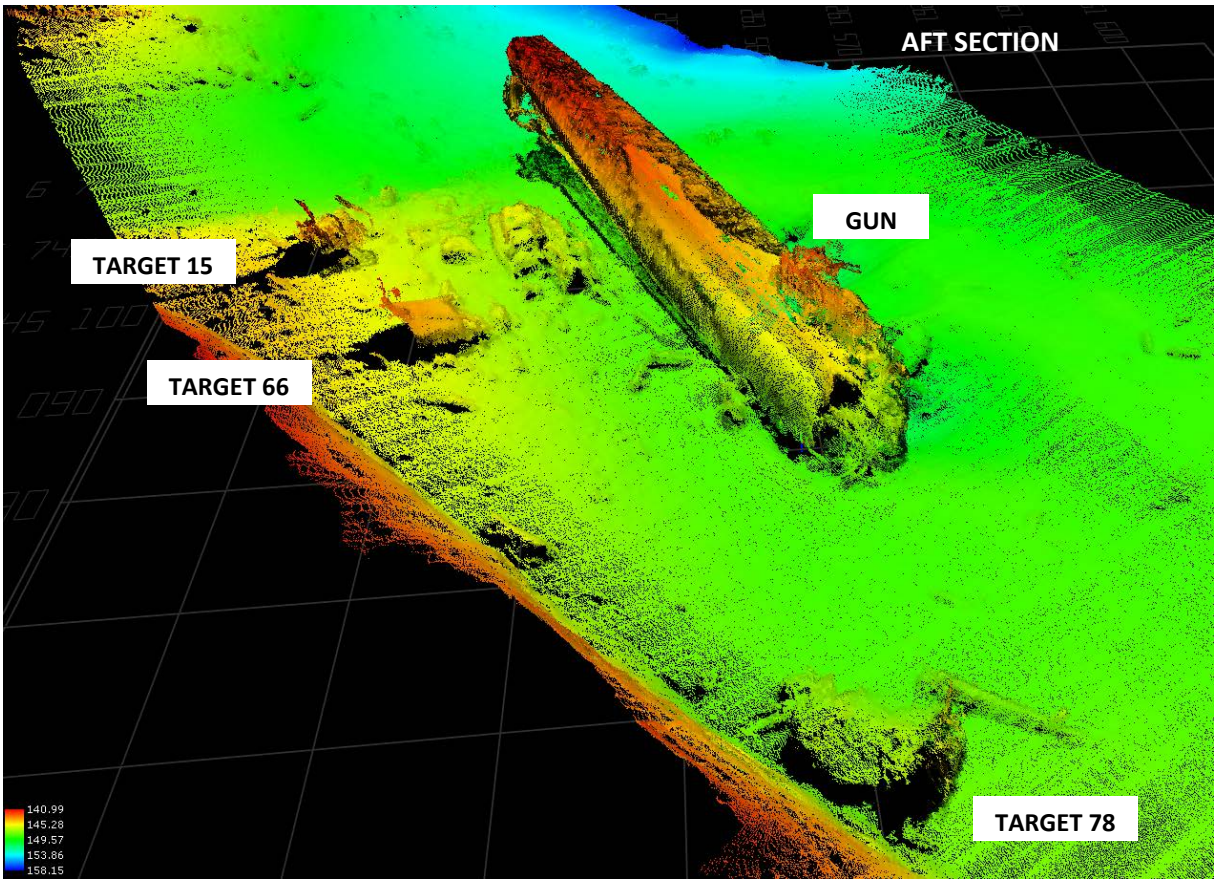
Figure 2 **The Aft section of U 864 with target 15, 66 and 88**

The search and mapping of the extended area 2000 x 2000 meters started on the 4th of January. A clear zone grid survey was carried out throughout the area which confirmed the findings from 2005 and 2006. No other major debris was found during the new scanning. The state of the art multi beam equipment was tailored to the clear zone grid survey requirements and gave excellent recordings for the more detailed video search and the debris identification process. There were no indications that a third section could be located on the seabed within the extended area of 2000x 2000 meters. Consequently the missing parts of the submarine were to be found among the major debris near the rear part of the wreck (Figure 2).

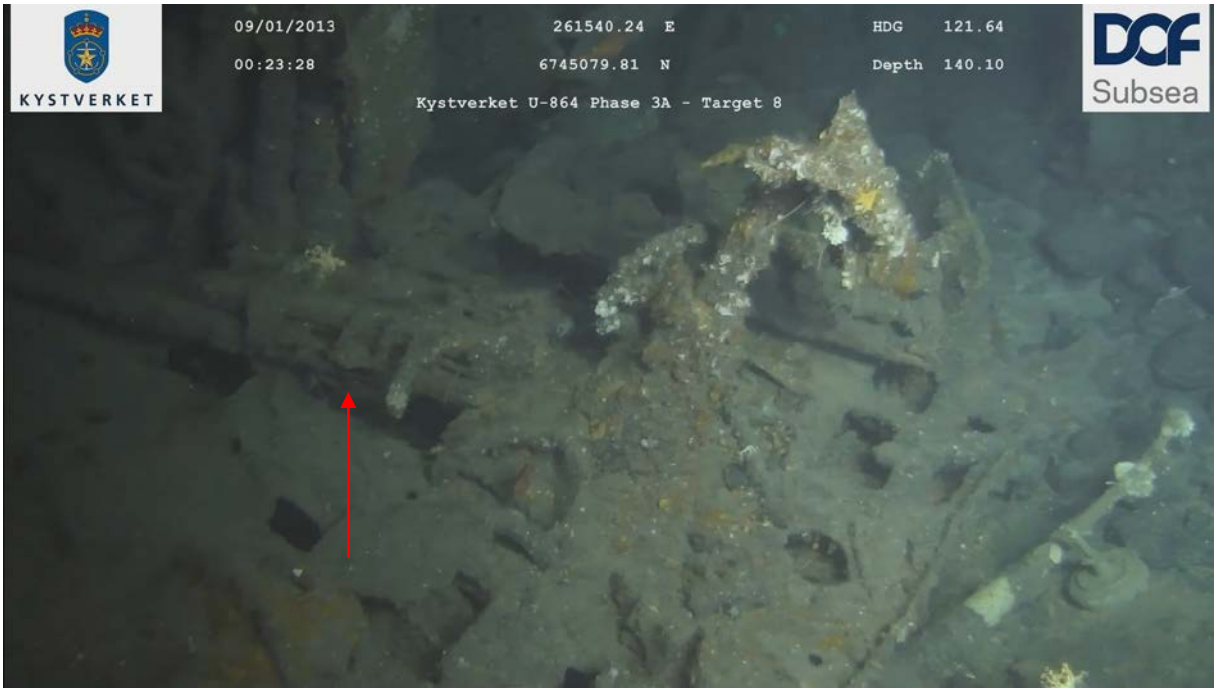
Figure 4 **One of the two Single barreled guns (red arrow), from the conning tower**

Only one gun can be positively identified among the debris. However it is likely to believe that the other one can be found among the numerous wreckages in the same general area, but not visible

As the main gun is clearly visible on the forward casing, and the aft gun is located on the aft part of the "winter garden" (Figure 3 to 5), the conclusion is that two of the guns have been identified on the wreck and the last one on the adjacent debris. This is an important finding as it proves that all major parts of the top of the superstructure have been located.

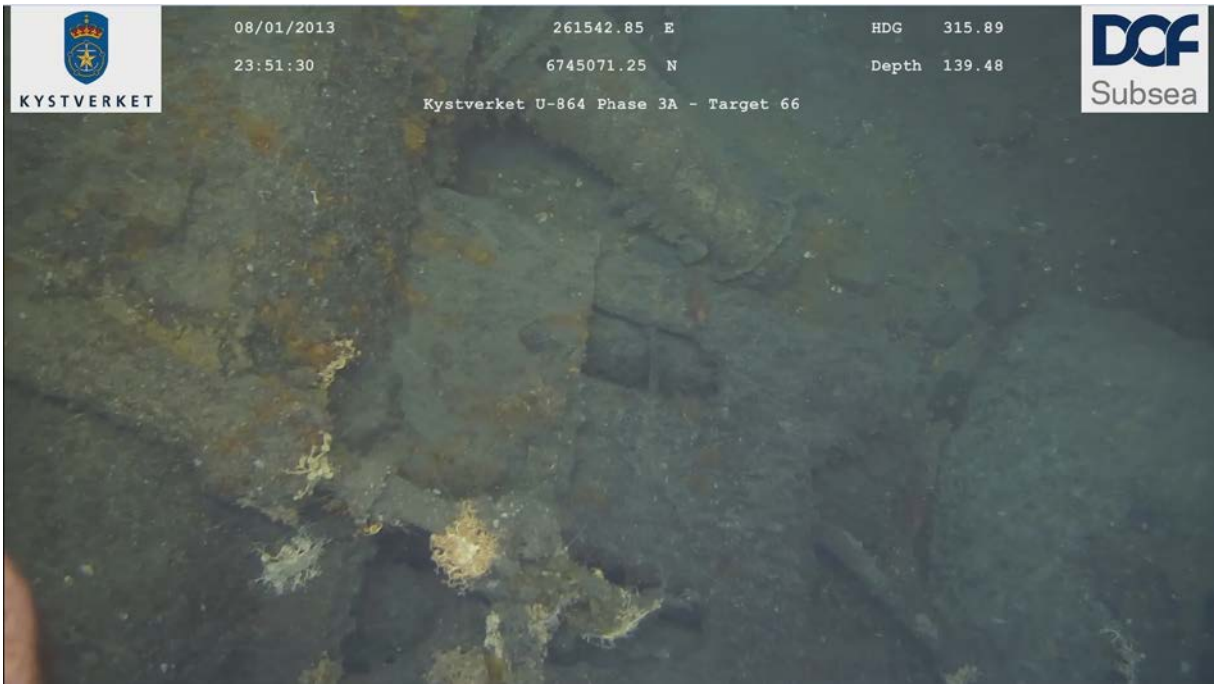
Figure 8 **Top of the periscope on the top of the conning tower**

For the purpose of this operation however, it is not mandatory to identify both periscopes as they are mounted onboard in a common structure of the hull. The metal tube on the Figure 7 shows a part of what is likely to be the observation periscope. The Figure 8 is taken from the top of the same section, shows what is believed to be the top of the observation periscope. Both periscopes are penetrating a solid support construction on the top of the conning tower with the mission to prevent vibrations in the periscopes when the submarine is operating on periscope depth at speeds in access of 4-5 knots.

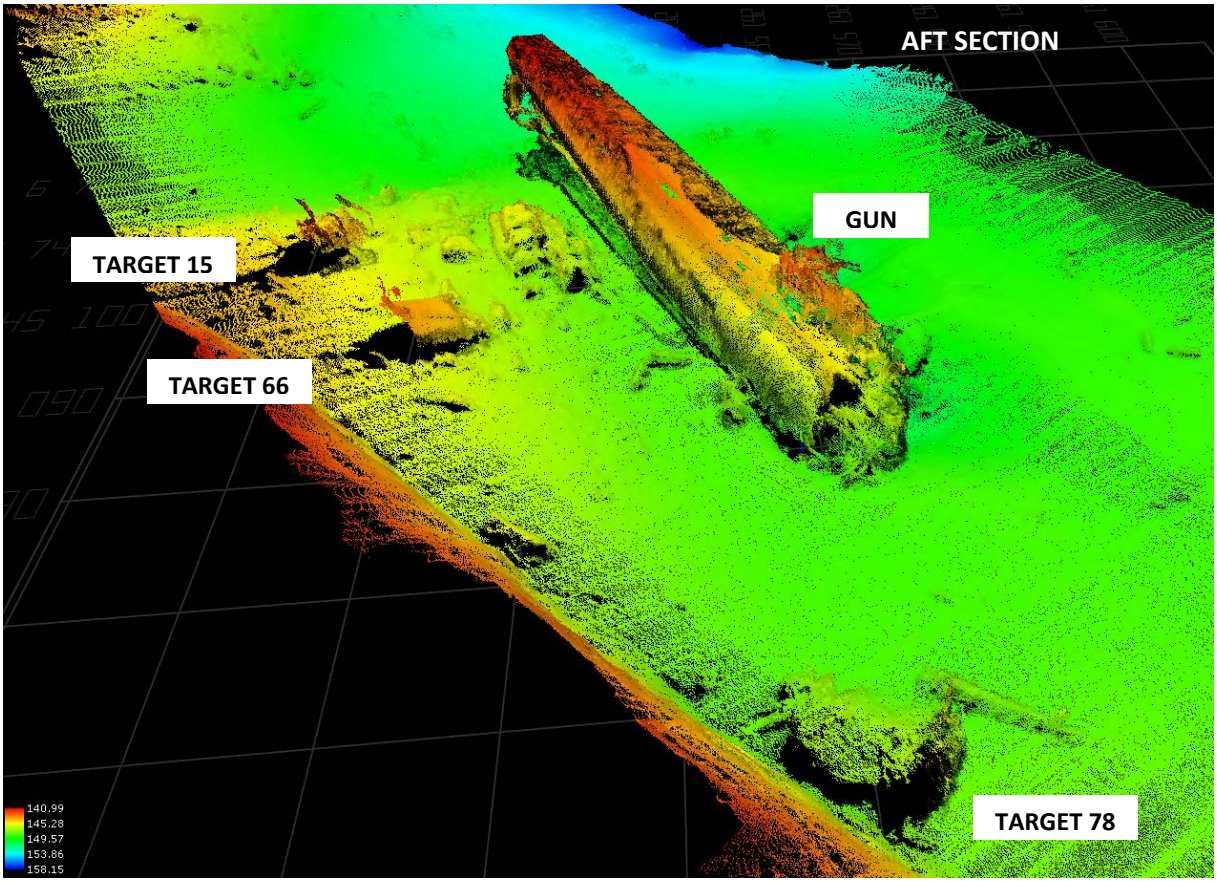
Figure 11 **The Aft section of U 864 with target 15, 66 and 88**

The effect of the warhead of the MK 8 torpedo has caused severe damage. The deformation of the conning tower indicates that the torpedo hit higher up than previously anticipated. The mid section is torn to pieces and the keel section is most probably less damaged than previously anticipated.

The identification of the significant parts attached to the mid section has mainly been done on or near the targets 66 and 78 (see Figure 11). Here we find the periscopes, the top bridge with navigation equipment, the conning tower, the snort mast and the small caliber gun from the aft part of the bridge.

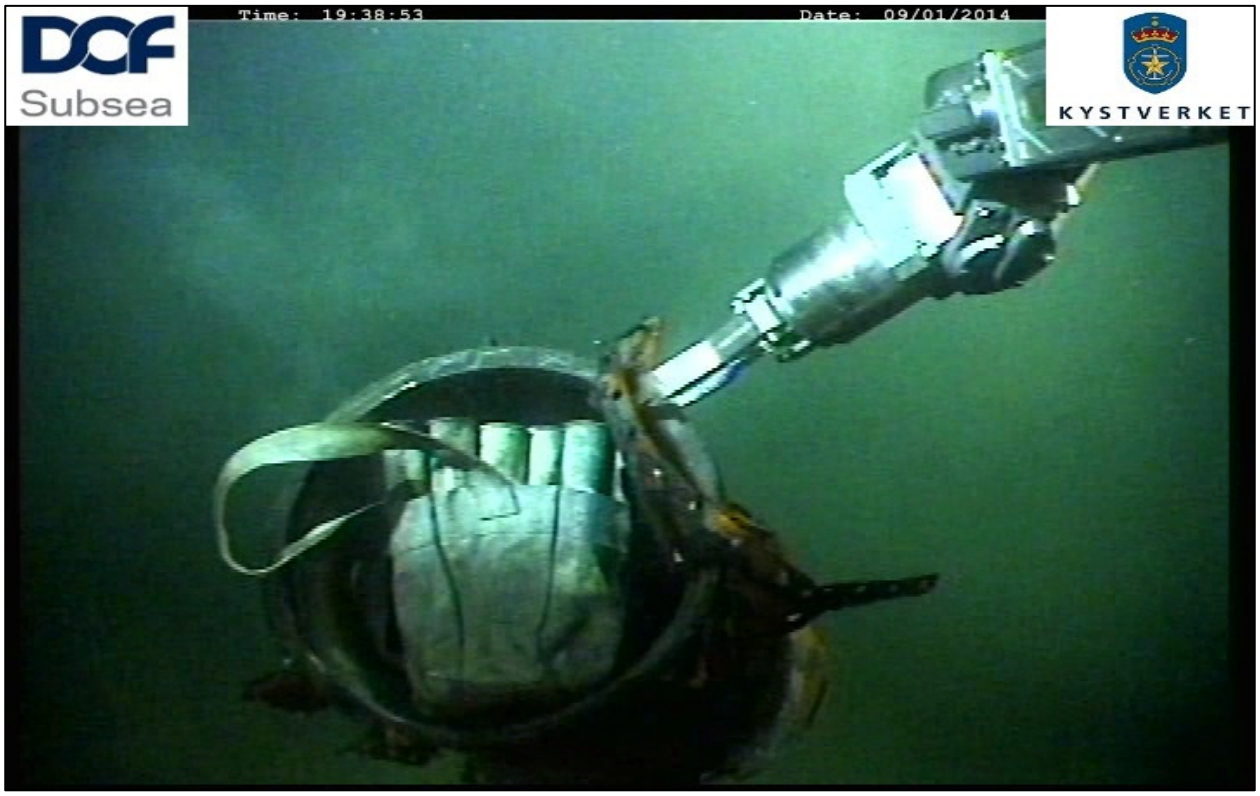
Figure 3.5 20mm ammunition being transported to the wet store area. Note the excellent condition of the satchel

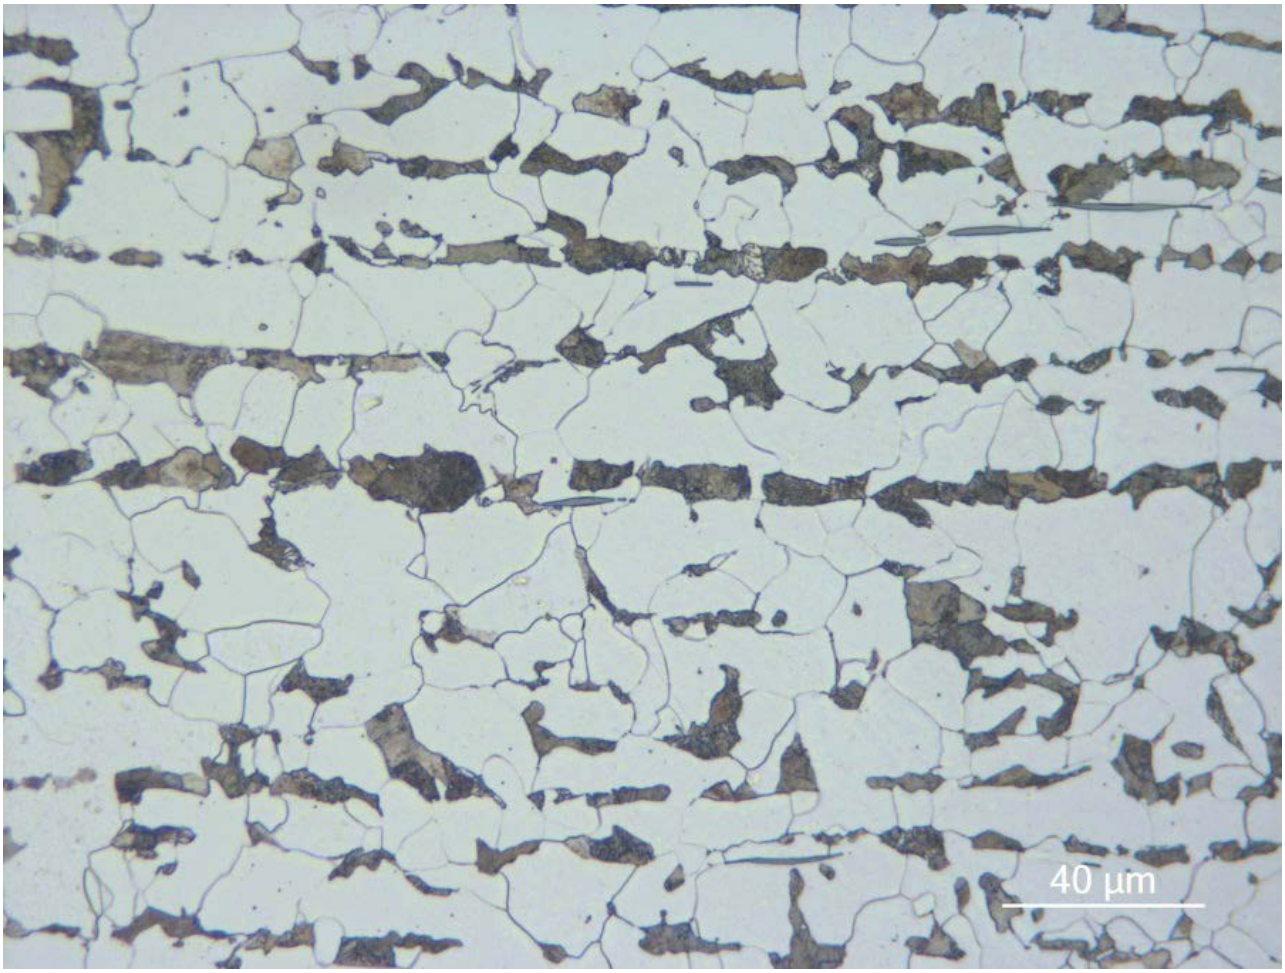
The samples were ground, polished and etched according to standard metallographic procedure. The microstructure consisted of a fine grained ferritic pearlitic microstructure. The material is most likely in as-normalised condition. Some intermetallic inclusions were observed e.g. MnS and oxides, as expected. Representative microstructures for the base material from both sides of the weld are shown in Figure 4 and Figure 5. The rolling direction appears to be parallel to the weld.

Figure 4: Microstructure longitudinal direction, etched in 2% Nital

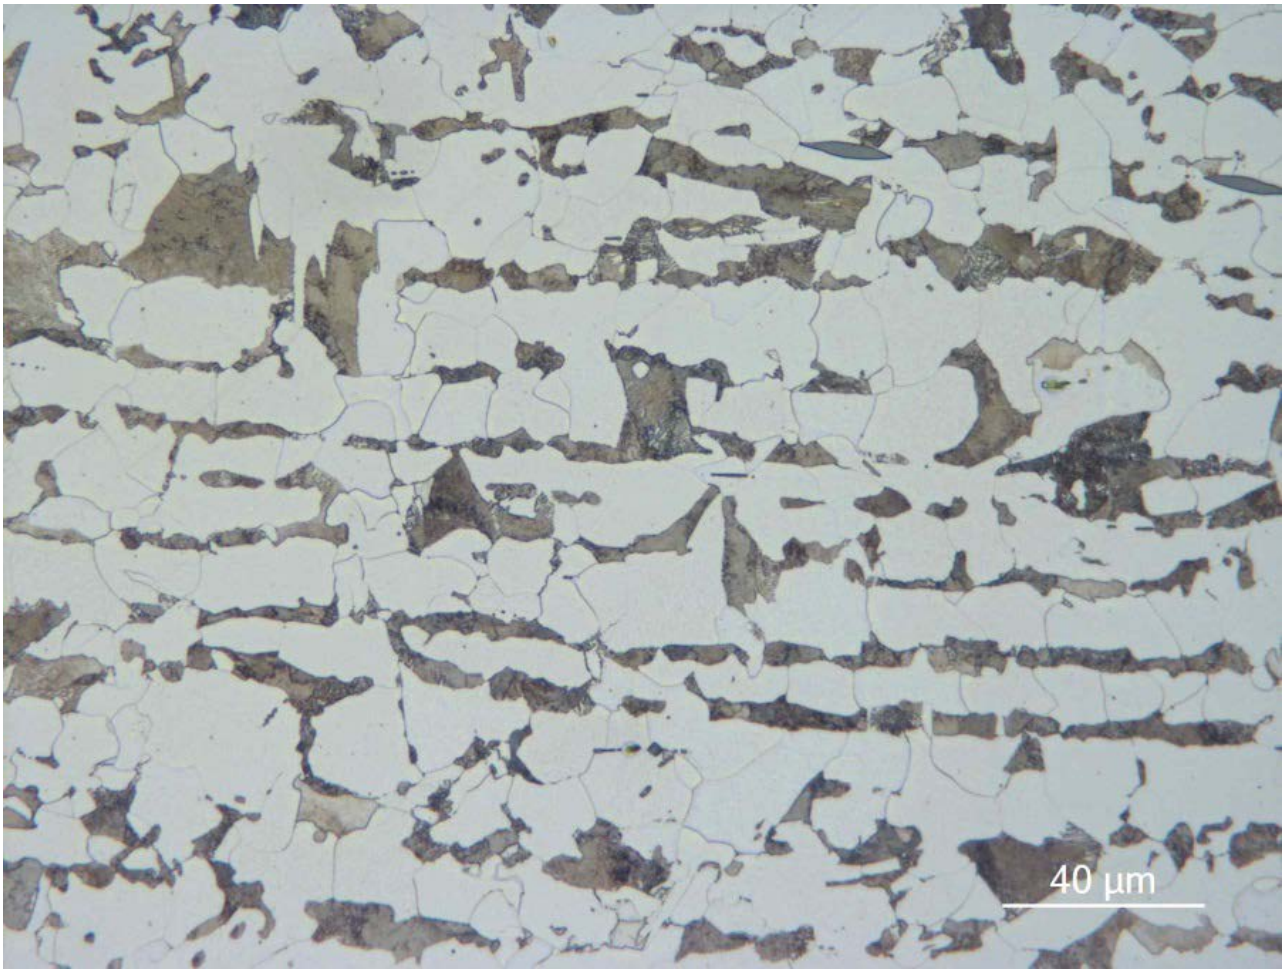
Figure 5: Microstructure transverse direction, etched in 2 % Nital

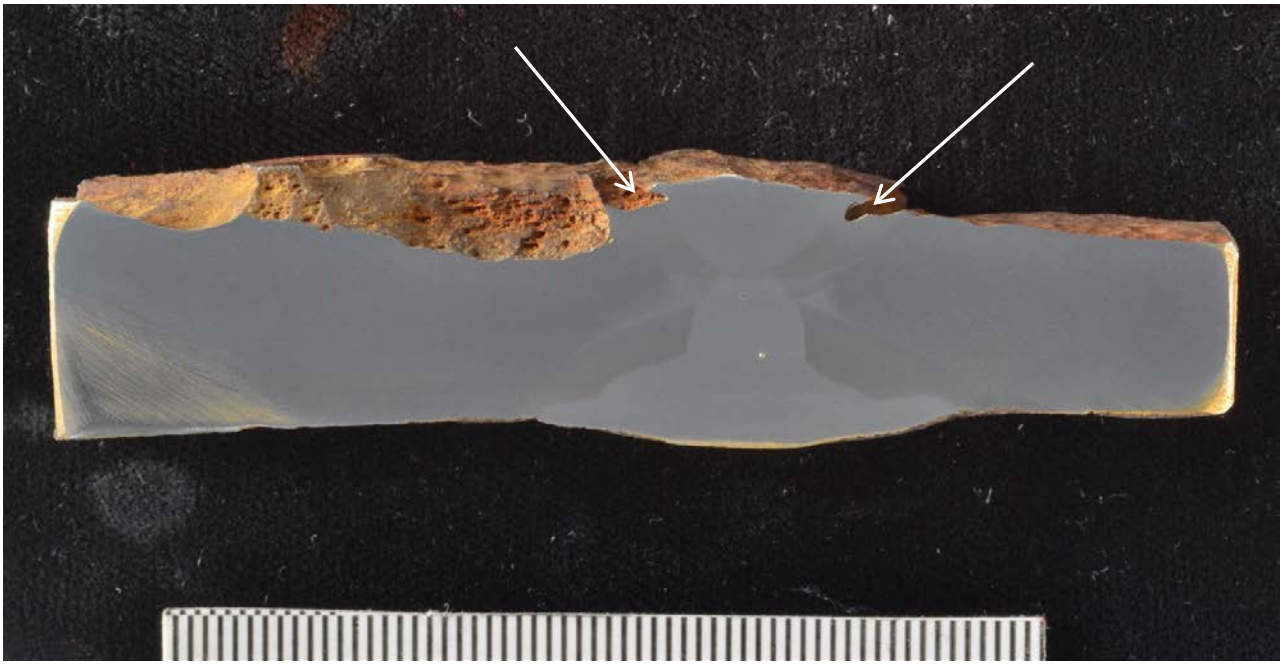
Figure 6: Macro section through the weld, taken as shown in Figure 1 (arrows indicate preferential corrosion attack close to weld)

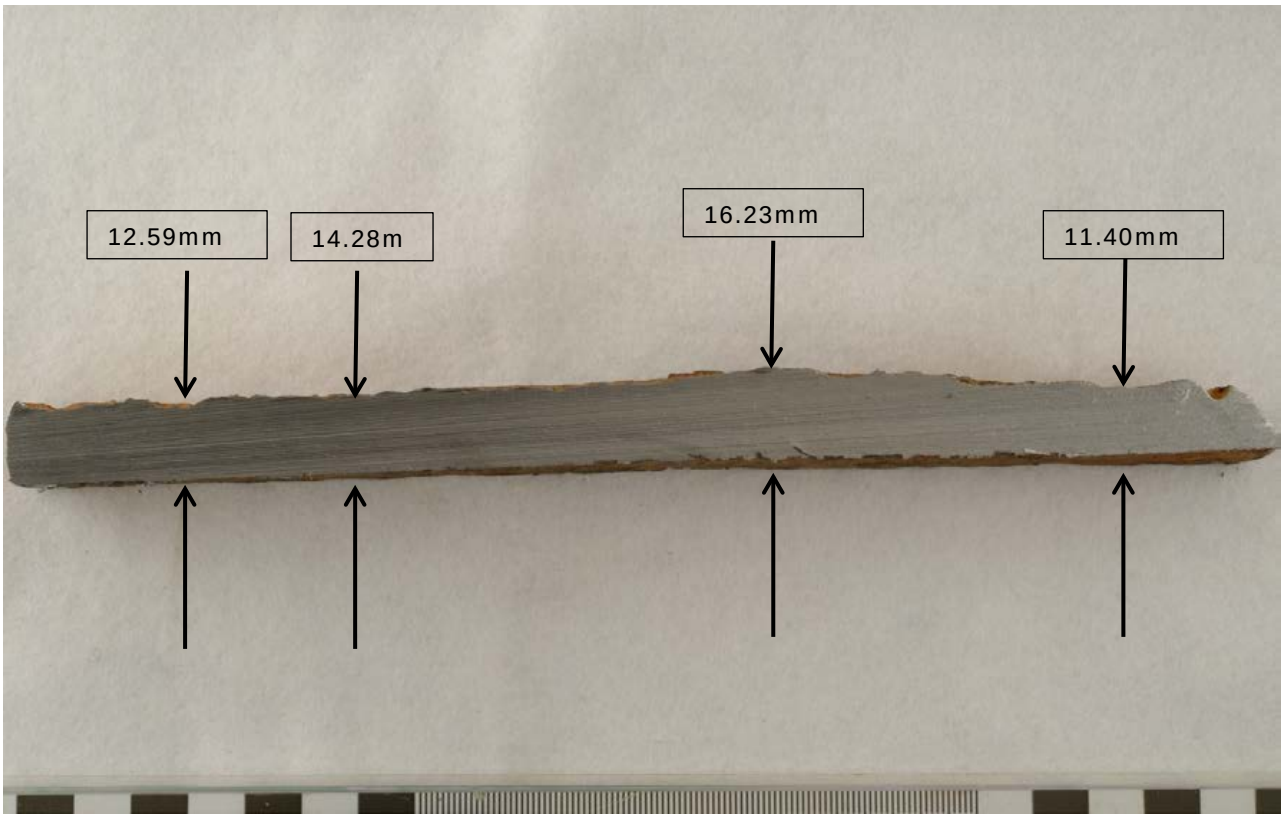
Thickness measurements were carried out in two different sections where thickness appeared visually to have been reduced the most. The sections were taken out as shown in Figure 1. The thickness was measured with a calliper and the thinnest part on the base material section had a thickness of 11.4 mm and the thickest part was measured to 16.3 mm, see figure Figure 7. On the macro section taken out in the weld area the thinnest part (pit) was measured to 10.6 mm and the thickest part 17.6 mm (Weld). Image of measurements on macro section is shown in Figure 8.

Figure 7: Thickness measurements on section cut as shown in Figure 1.

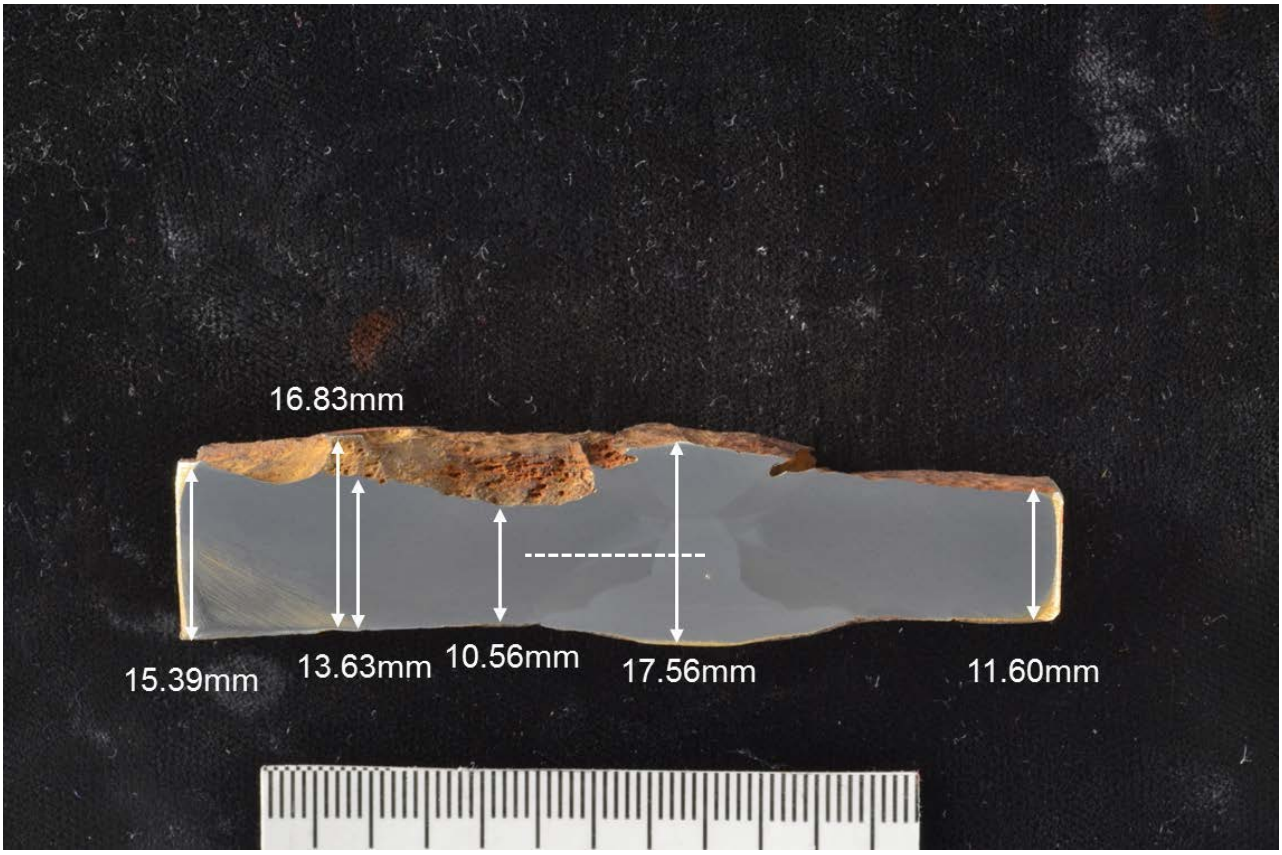
Figure 8: Thickness measurements on macro section Figure 1 (white line indicates position to hardness measurements)

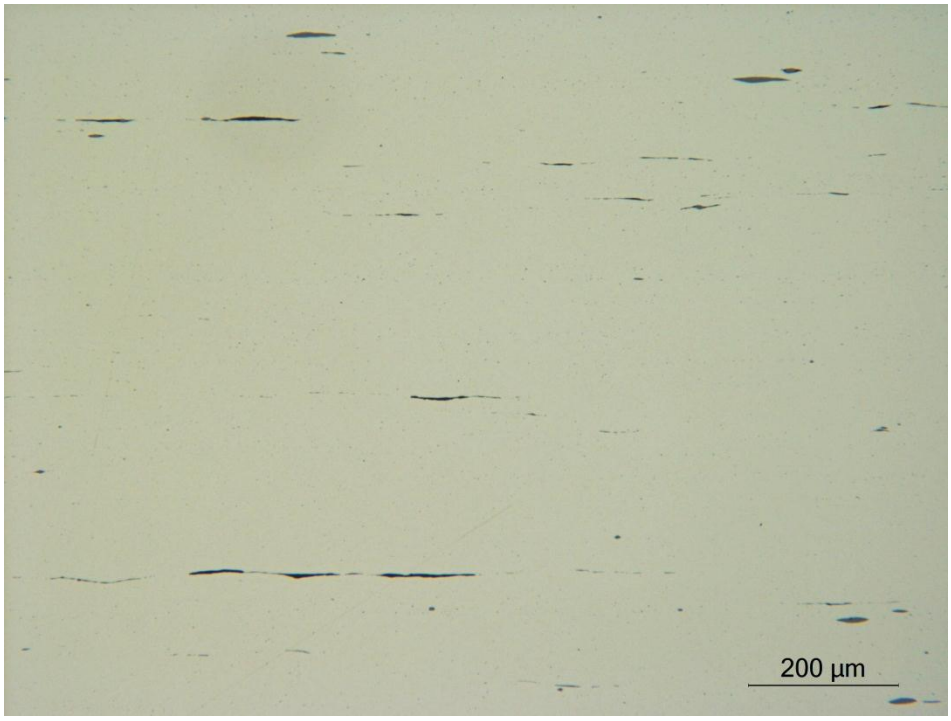
Figure 3: Metallographically prepared sample in as polished condition shows non-metallic inclusion in the plate material. Magnification 100X.

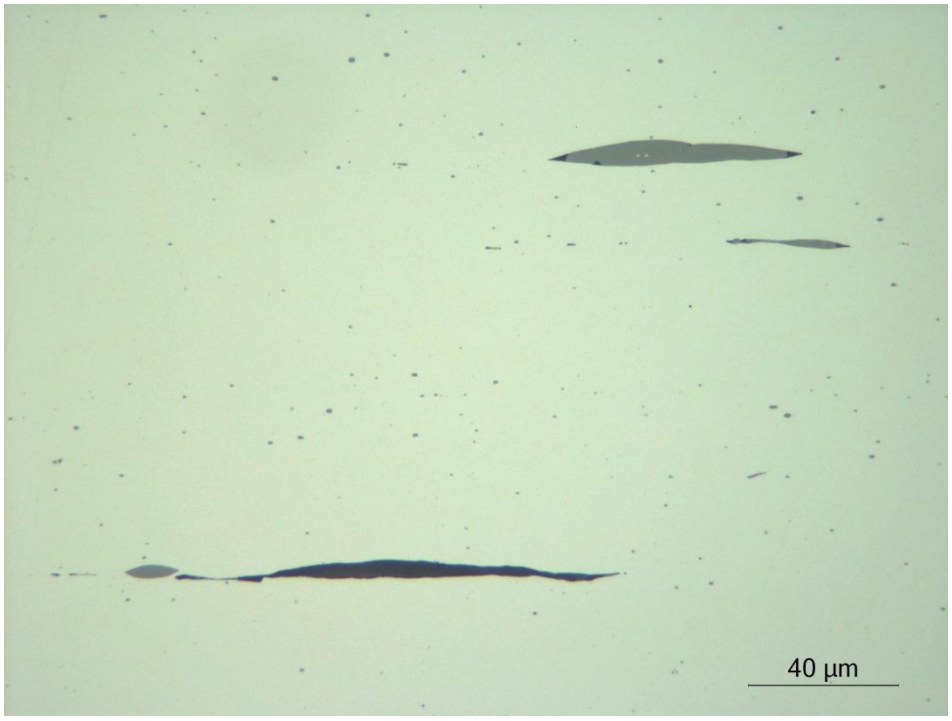
Figure 4: Close-up of Figure 3. Magnification 500X.

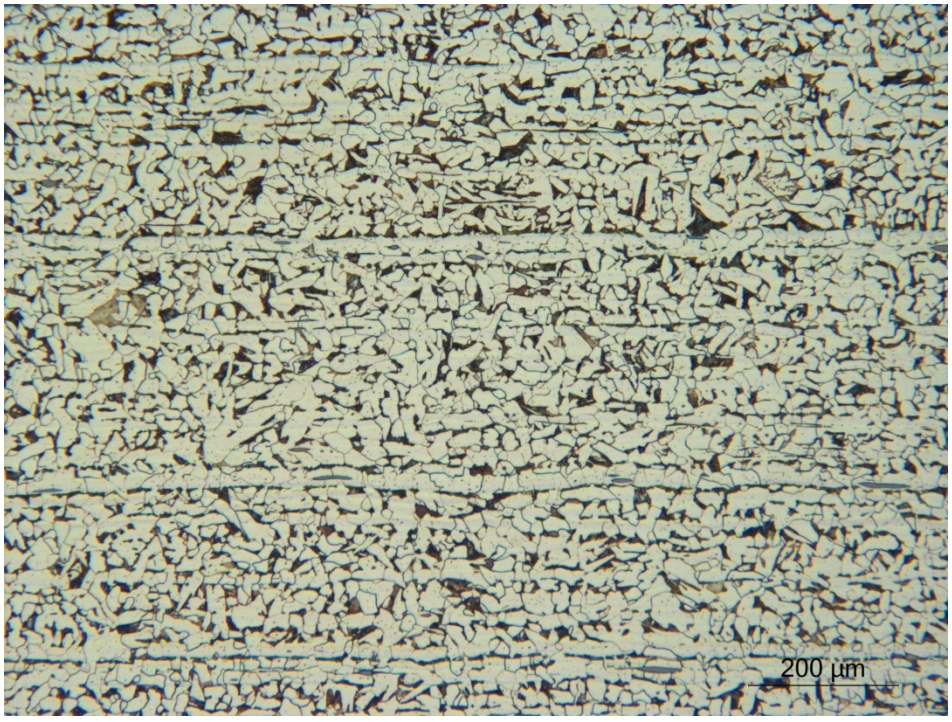
Figure 5: Microstructure representing the plate material consisting of ferrite and pearlite in as normalized condition. Magnification 100X.

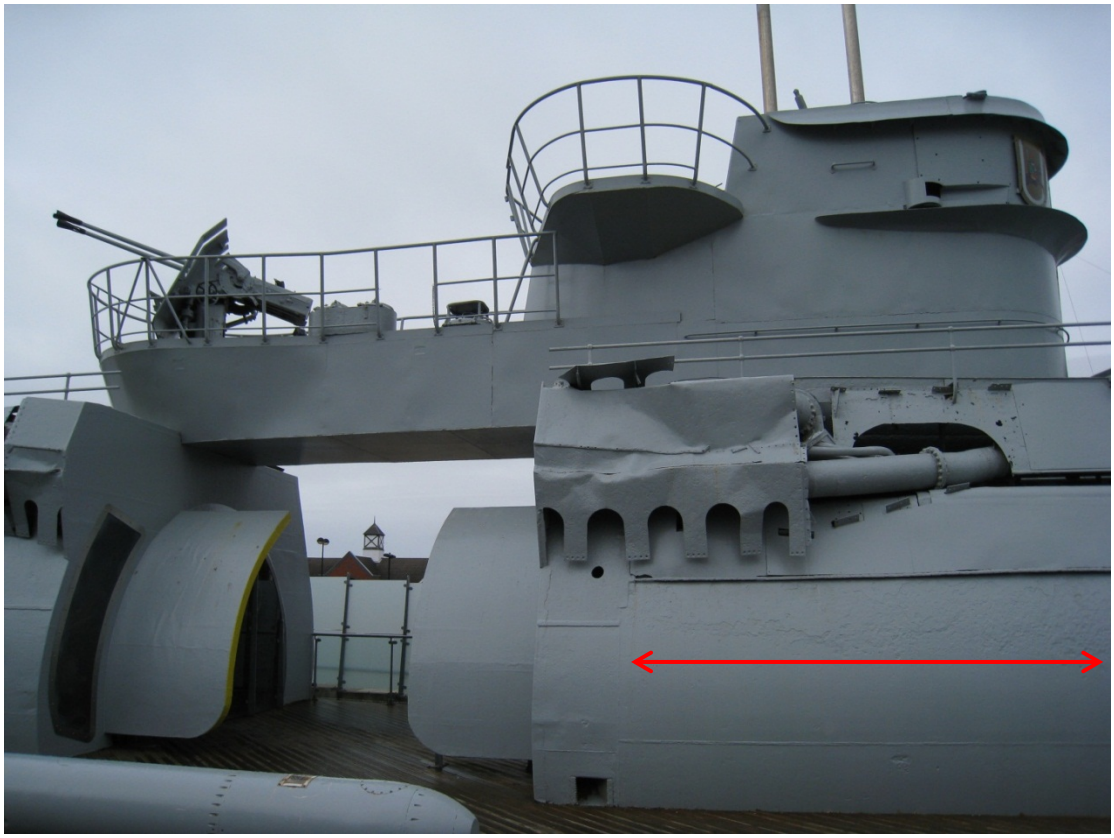
The thickness of the steel in the saddle tank/casing shell, spanning from the area immediately forward of the conning tower to the area immediately aft of it, was measured to be 25-26 mm (See figure 3). The relatively thick steel in this area is quite likely due to repairs performed after damages during the war. In other areas of the casing the thickness is 5-6 mm. Otherwise the casing is in poor condition due to a high degree of general corrosion and detached strut connections due to corroded joints.

Figure 3: Arrow showing the span of the area with increased shell plating thickness.

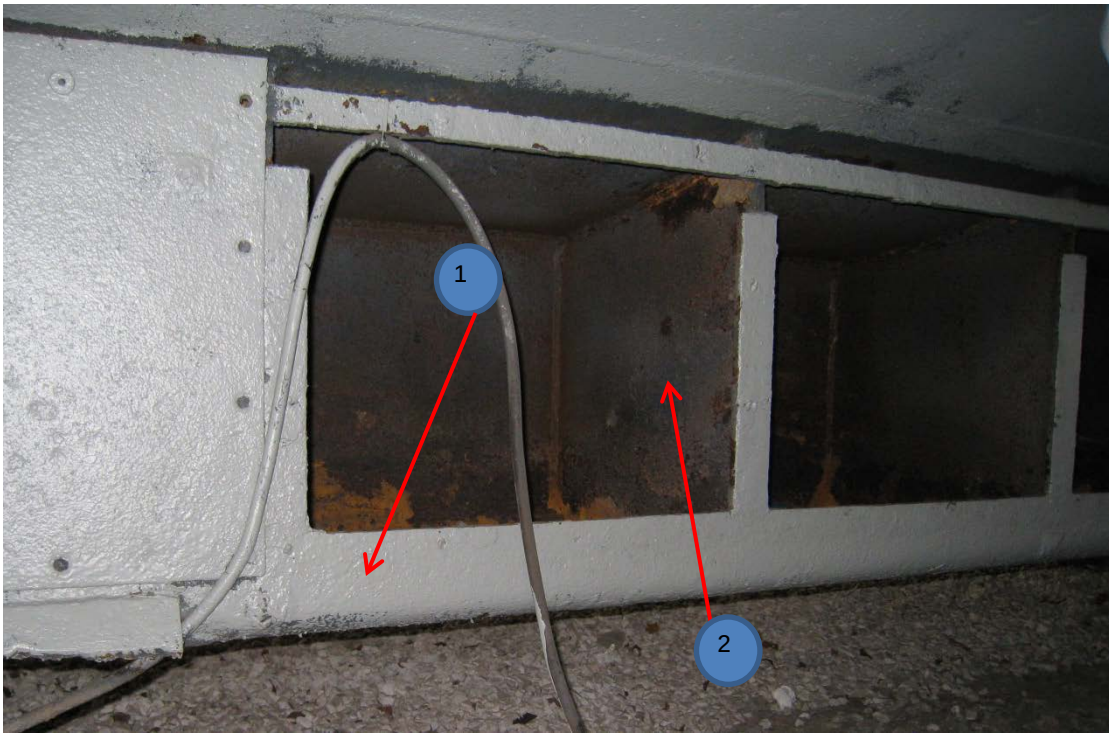
Figure 6: Picture of the keel ballast/storage compartment. Looking from port to starboard.

The steel thickness of the side and bottom of the keel is approximately 15 – 16 mm. In most areas there is some corrosion (See arrow one in figure 6).

The keel's vertical inner plates are all measured to be 11.5 mm. Moderate/minor amounts of corrosion can be found on them (See arrow two in figure 6).

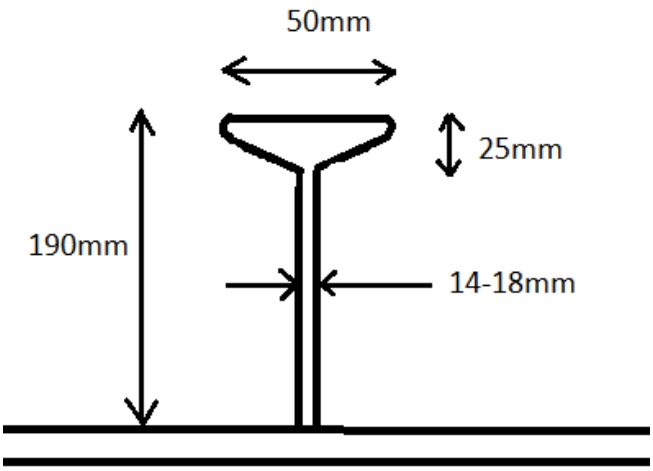
- The shell and transverse frames comprise the main structure
- The transverse plates in the keel are assumed to be welded directly beneath the transverse frames and will therefor transfer the loads directly to these frames.
- There is some corrosion on the inside of the pressure hull
- Rough measurements are performed on the internal structure (See figure 12)

Figure 12: Approximate dimensions of the ring-stiffeners (frames) inside the pressure hull
